REPORT TO

GEOTECHNICAL INVESTIGATION

KINGSBURGH EXTENSION 9

SEPTEMBER 2017

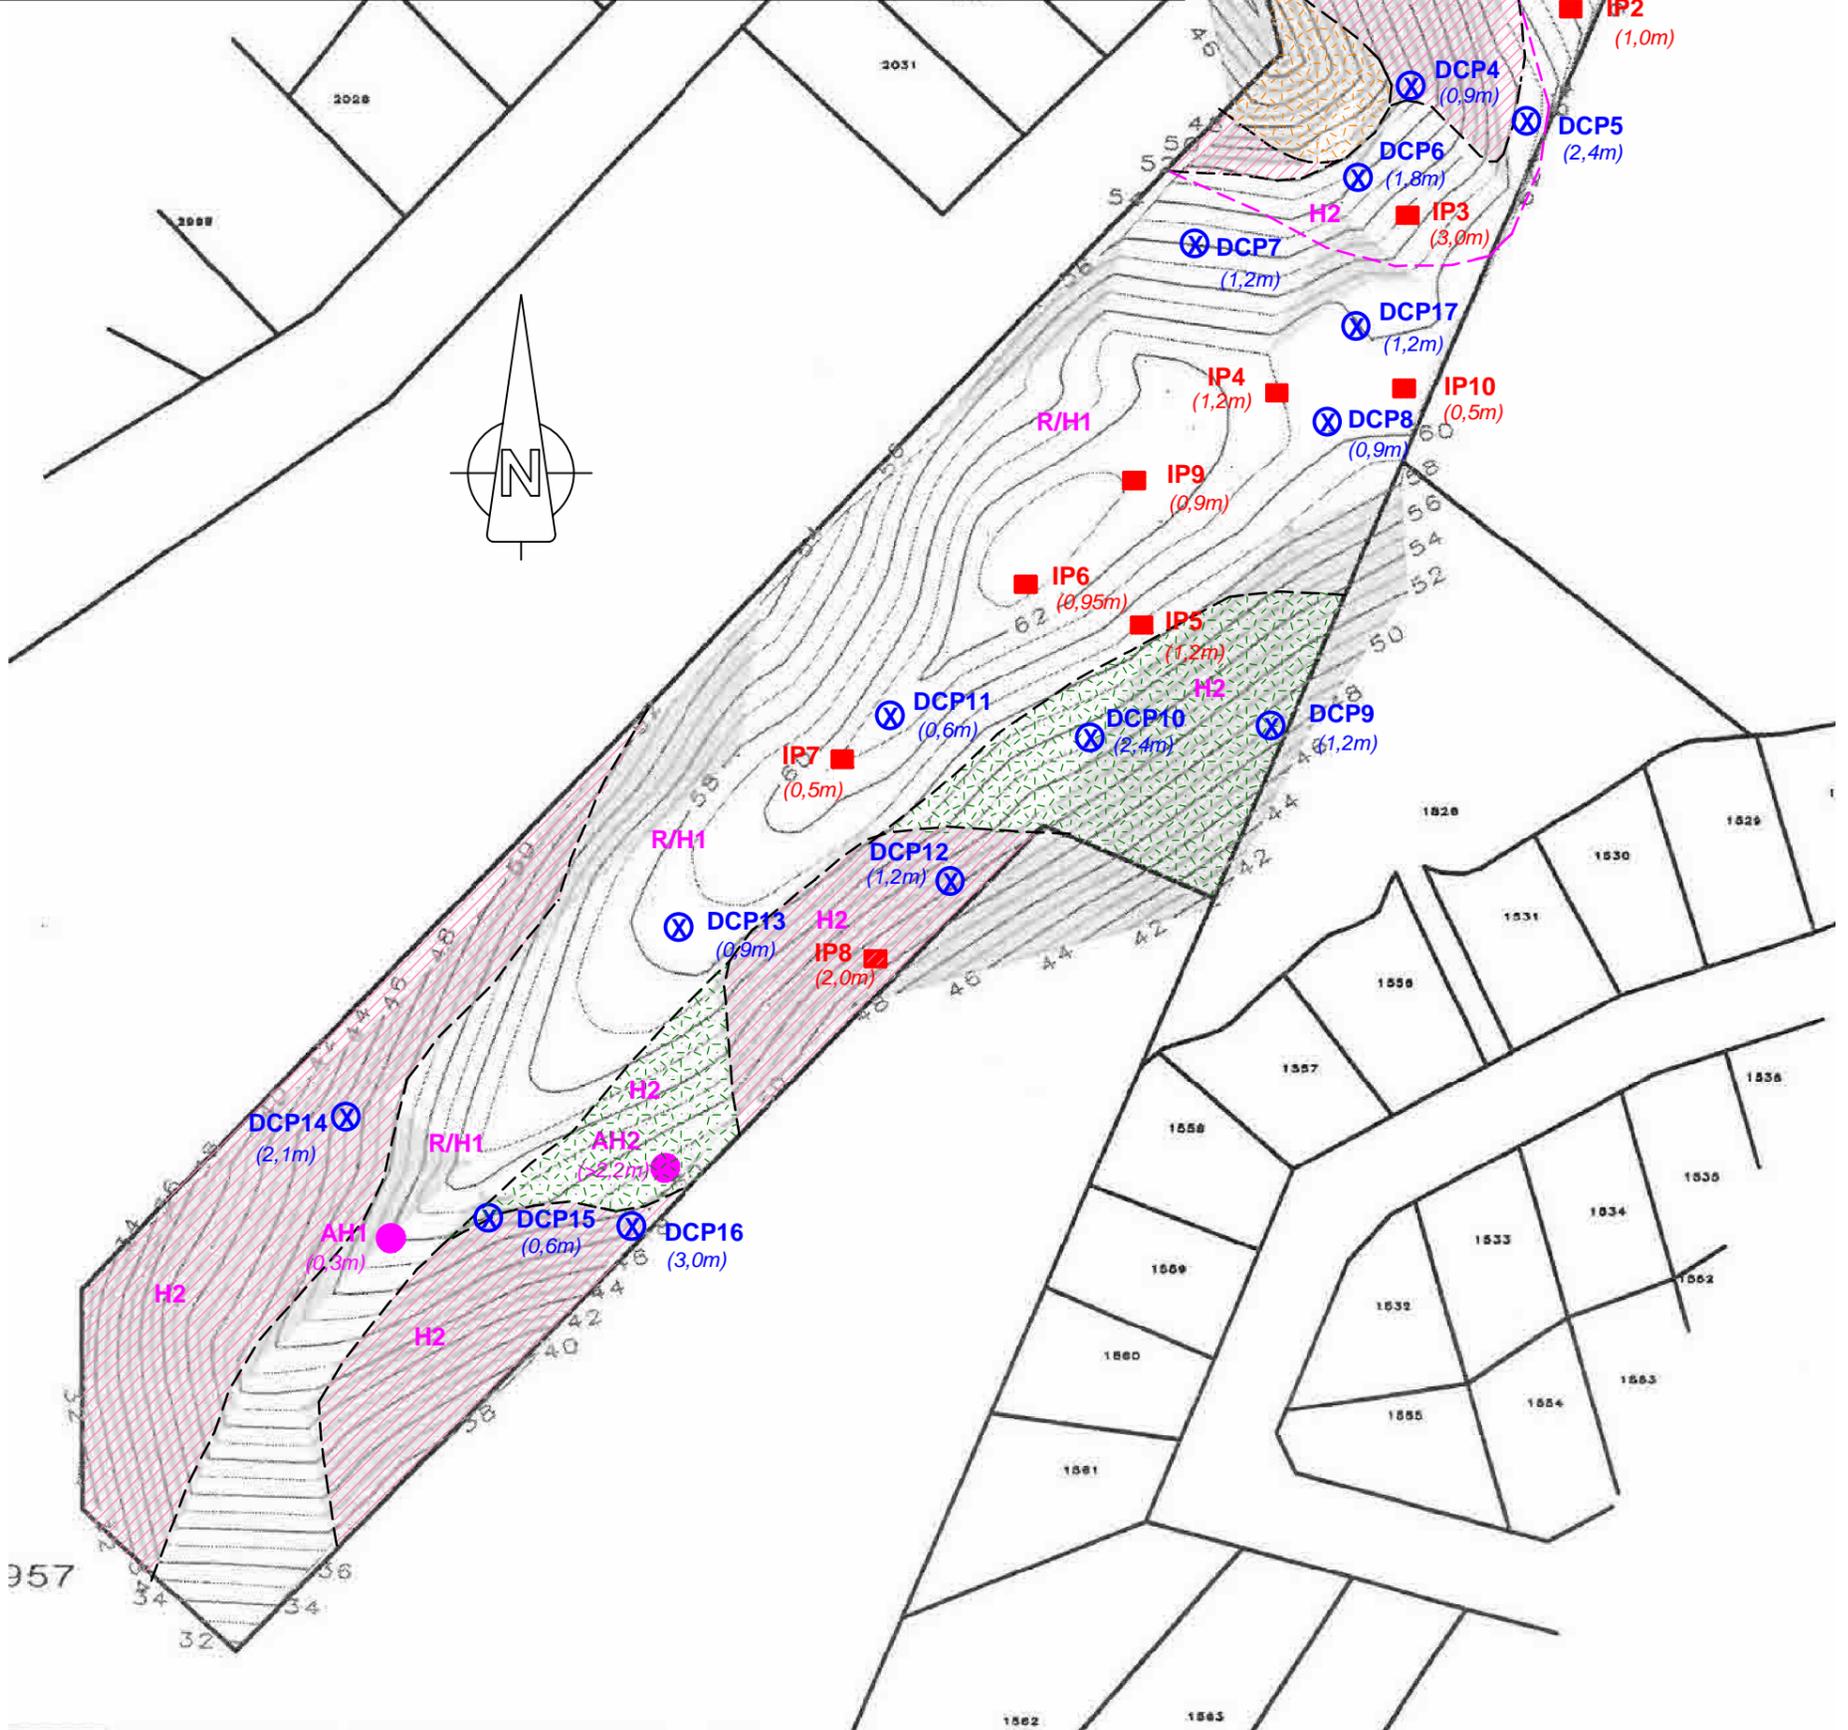
DRAWINGS 31873-A/02, B/02 & C/02
Geotechnical Site Plans

Drawings 31873-A/02, B/02 and C/02 of this report has been produced to illustrate the variation in geotechnical conditions across the site.

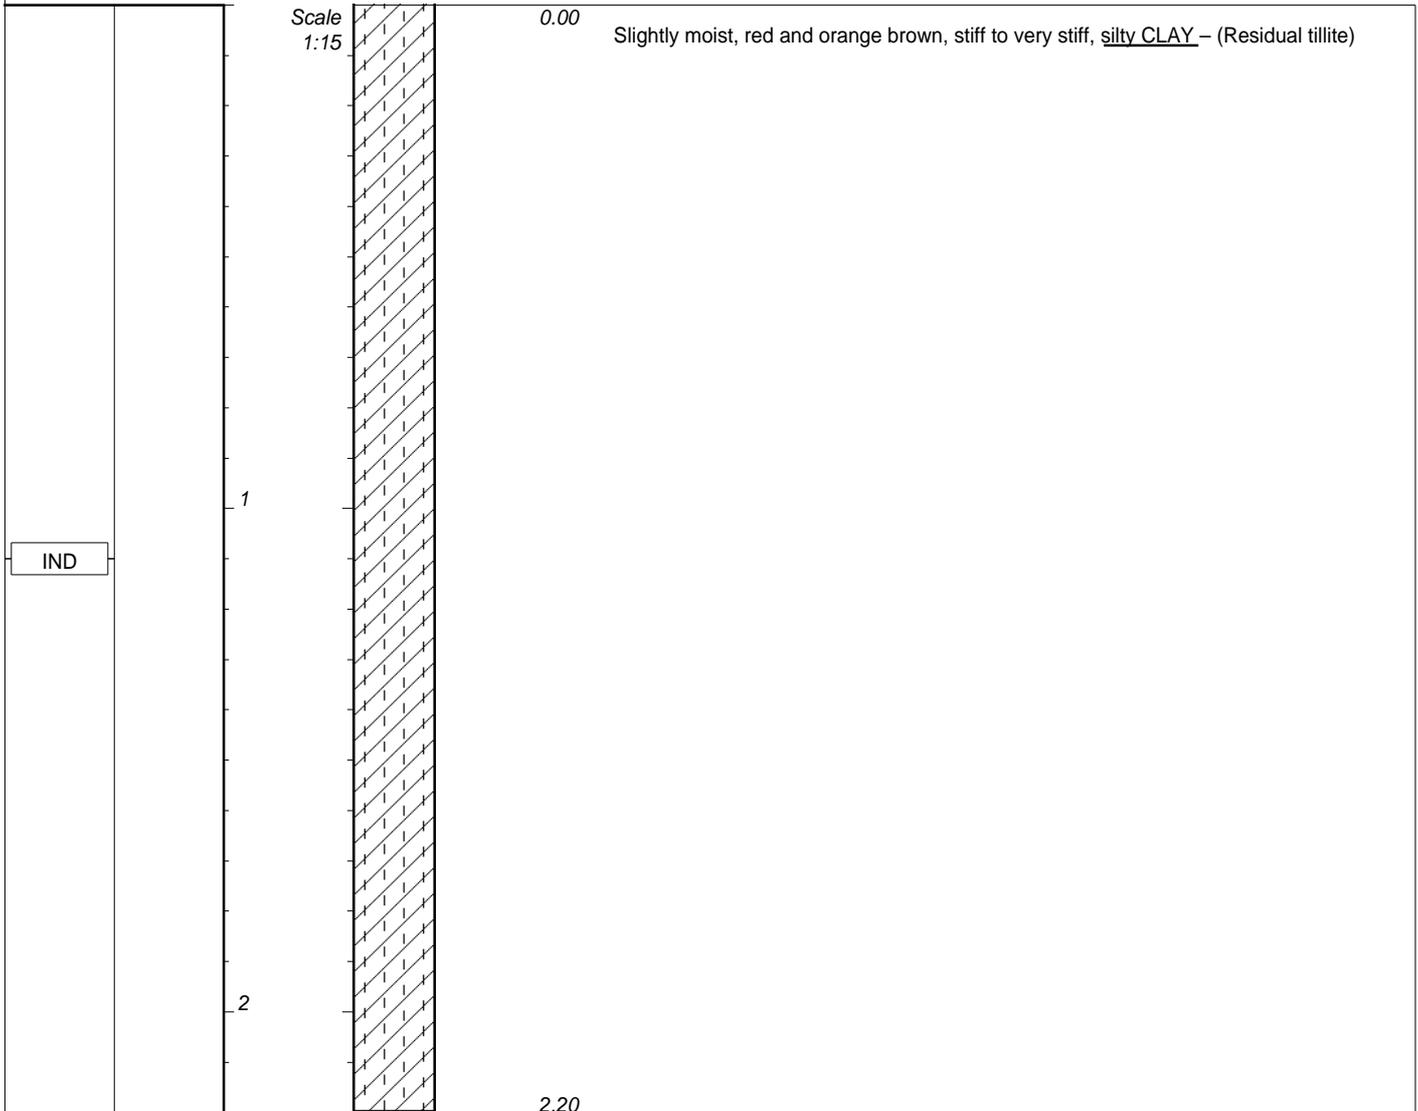
HOLE No: AH 1

- 1) Hand auger refusal encountered in stiff material.
- 2) No groundwater seepage encountered
- 3) Samples taken from 0.00-2.20m (INDICATOR)

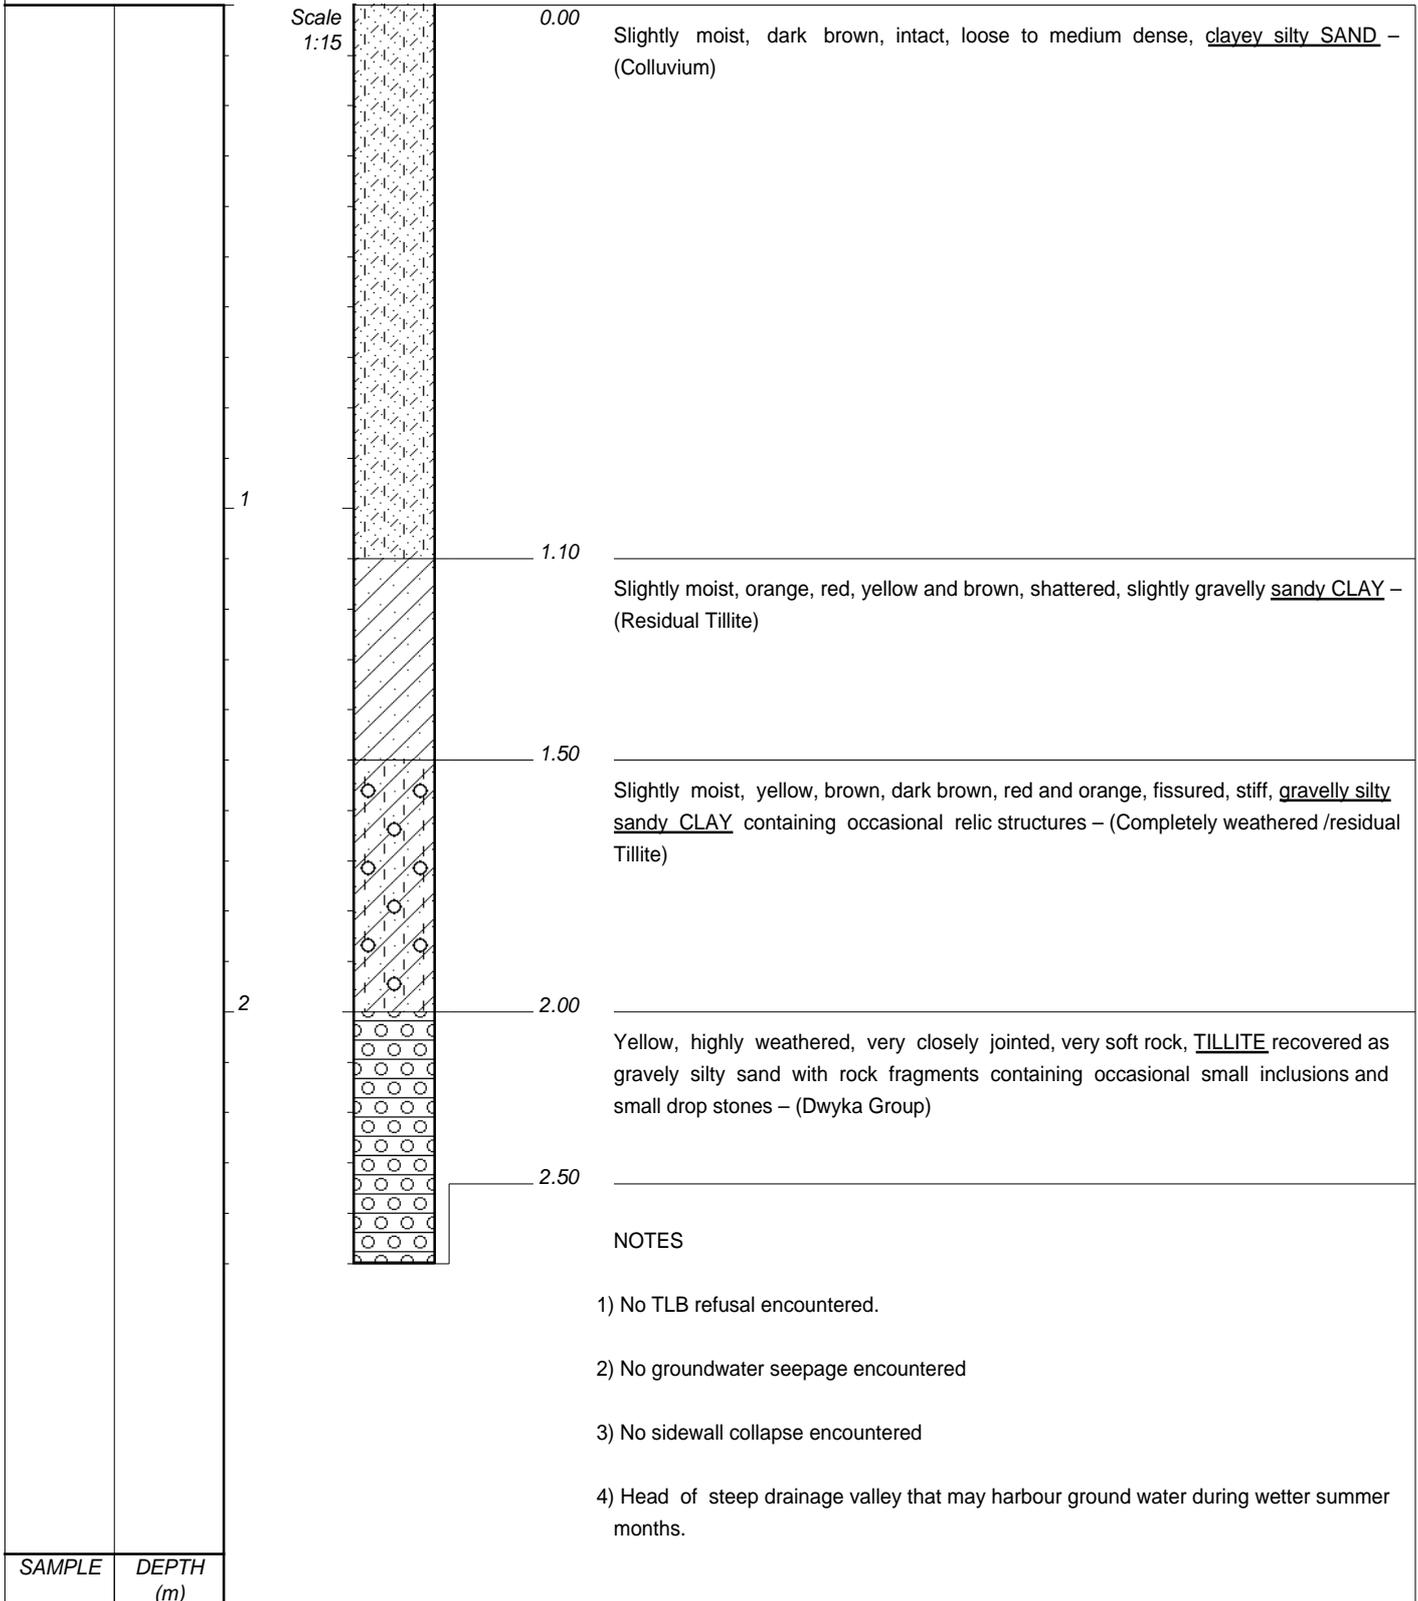
- 1) No TLB refusal encountered.
- 2) No groundwater seepage encountered
- 3) No sidewall collapse encountered
- 4) Head of steep drainage valley that may harbour ground water during wetter summer months.

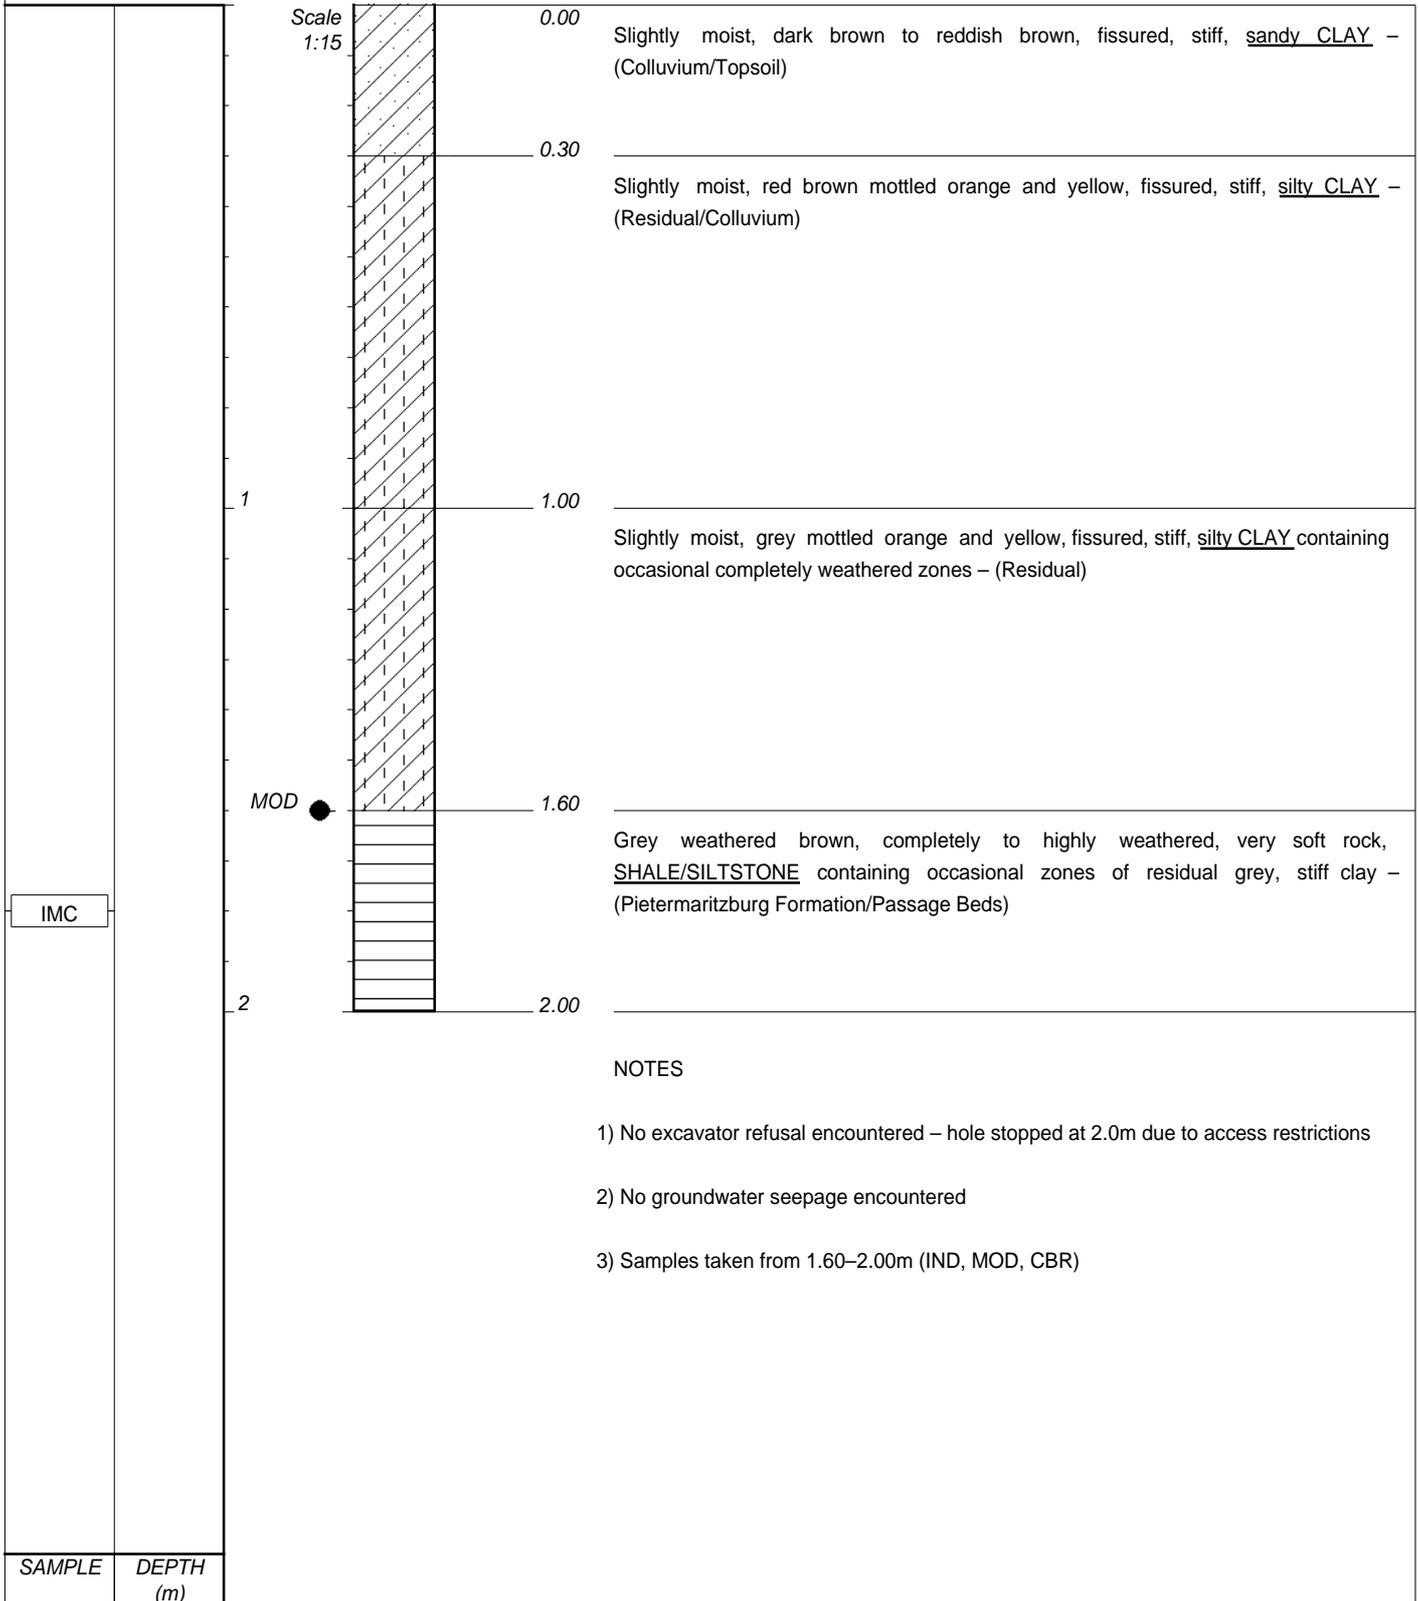
0.00 Slightly moist, dark brown to reddish brown, fissured, stiff, sandy CLAY - (Colluvium/Topsoil)

0.30 Slightly moist, red brown mottled orange and yellow, fissured, stiff, silty CLAY - (Residual/Colluvium)

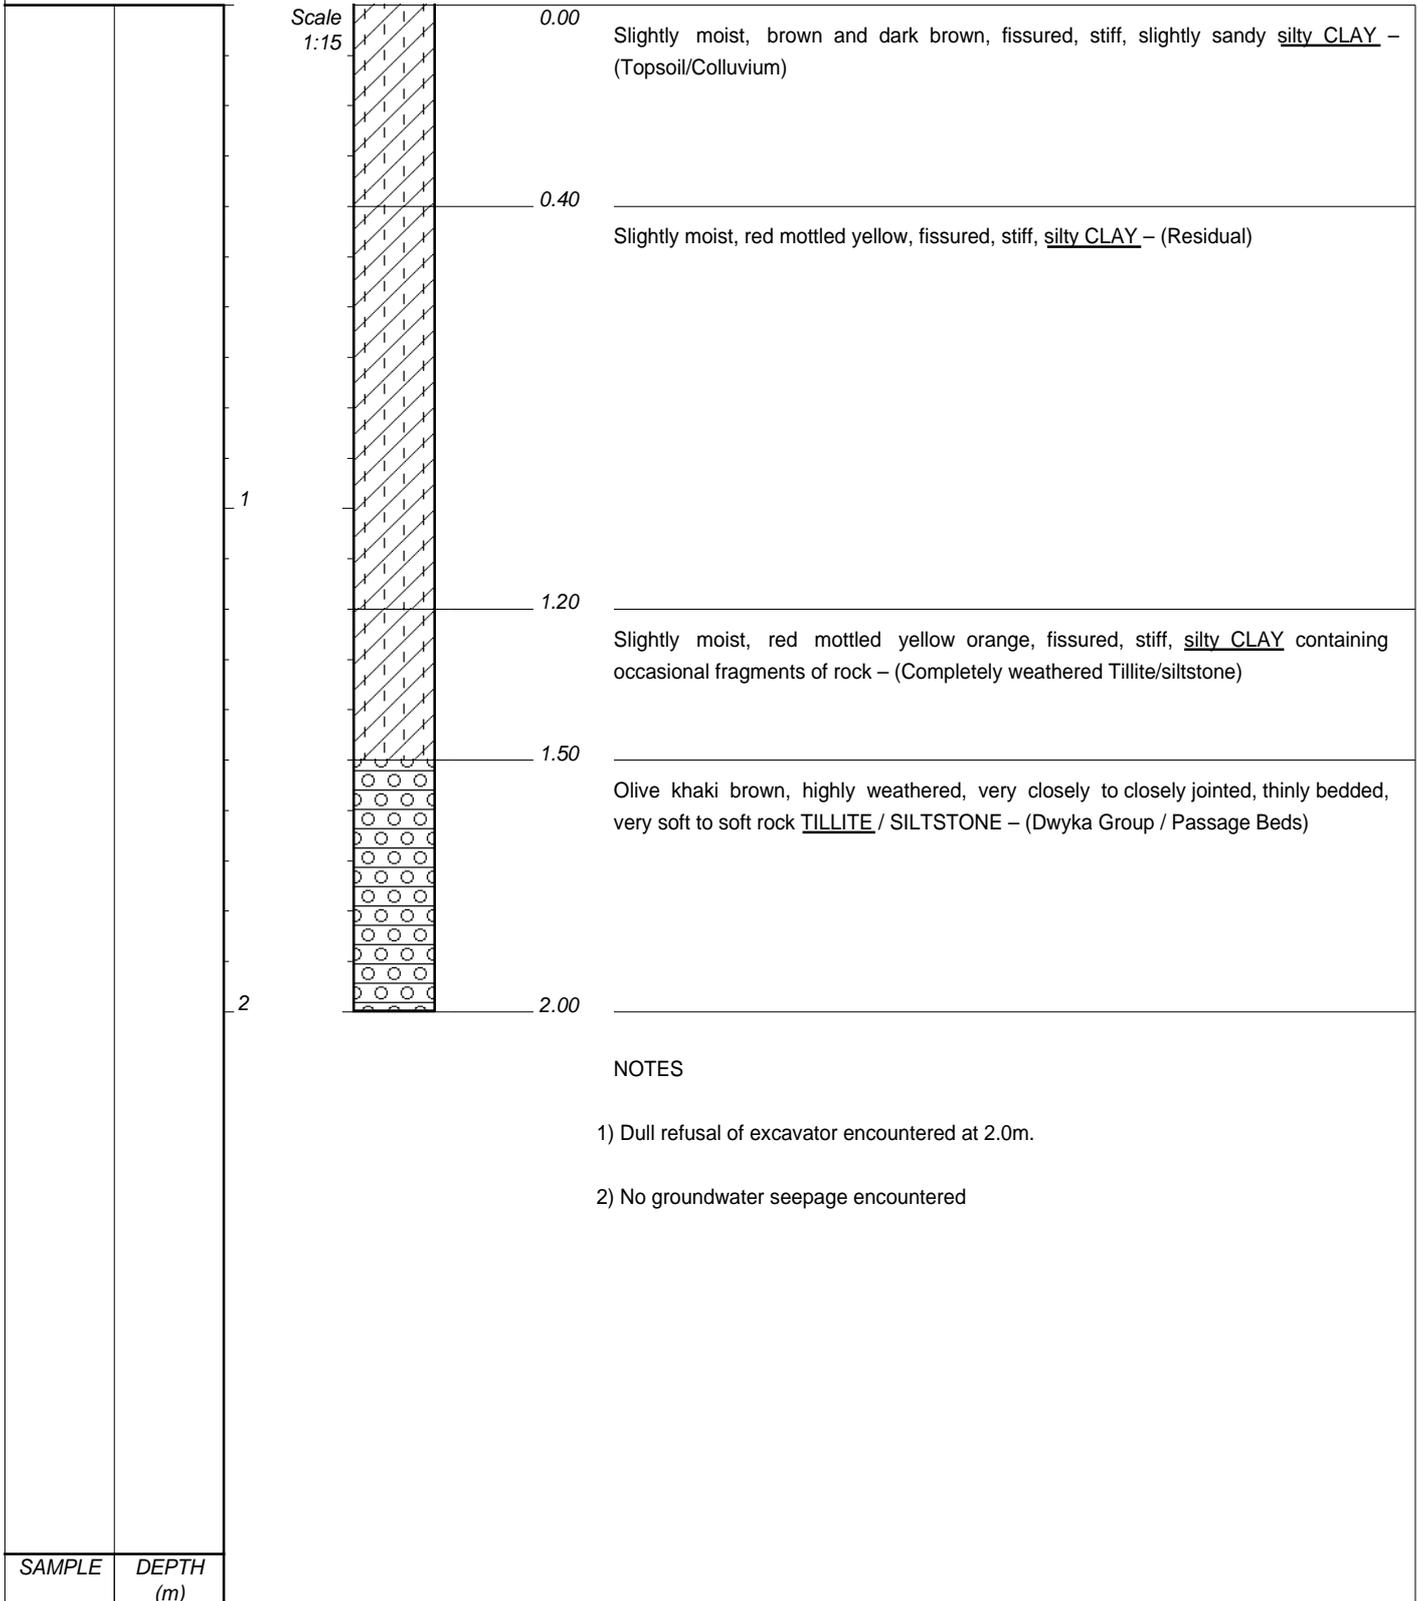
- 1) Dull refusal of excavator encountered at 2.0m.
- 2) No groundwater seepage encountered

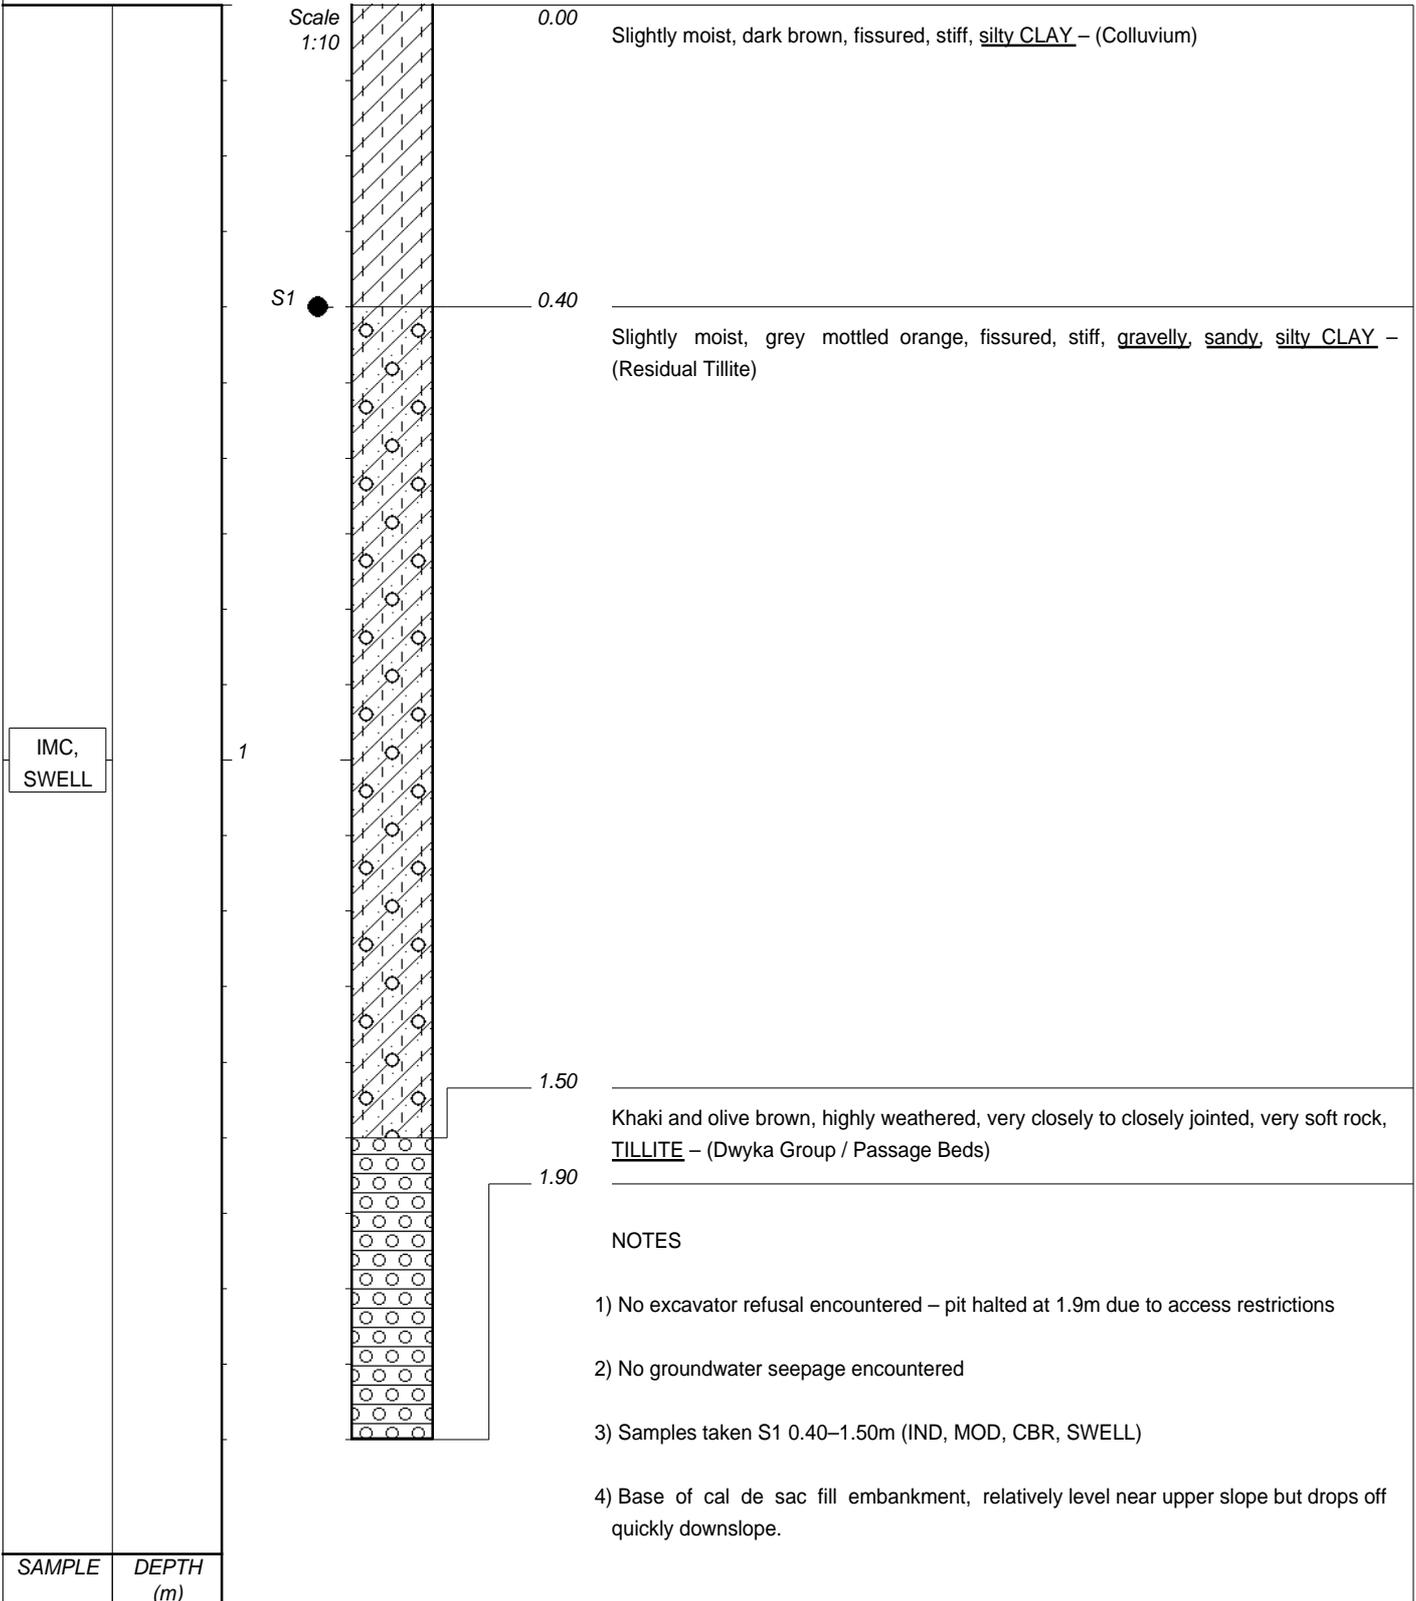
- 1) No excavator refusal encountered – pit halted at 1.9m due to access restrictions
- 2) No groundwater seepage encountered
- 3) Samples taken S1 0.40–1.50m (IND, MOD, CBR, SWELL)
- 4) Base of cal de sac fill embankment, relatively level near upper slope but drops off quickly downslope.

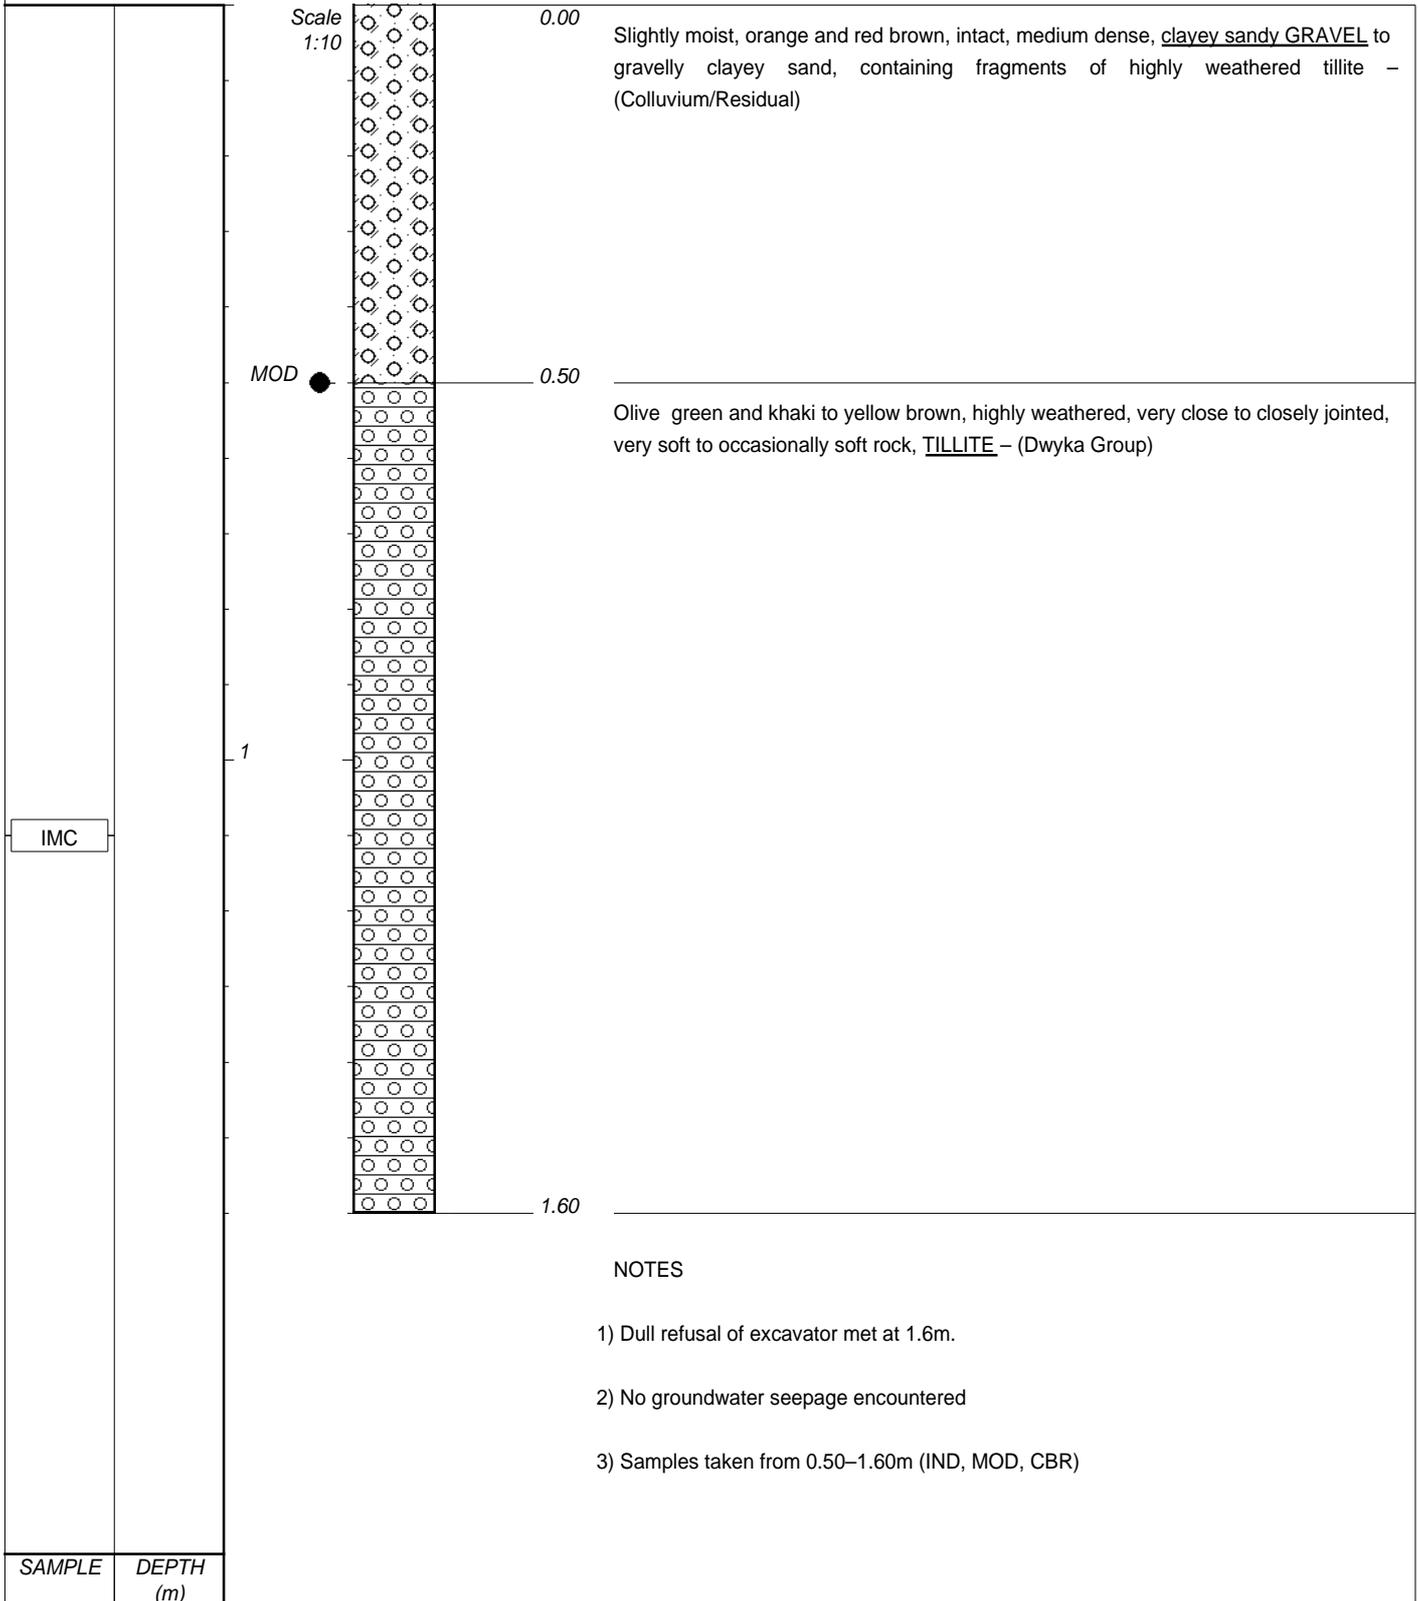
- 1) Dull refusal of excavator met at 1.6m.
- 2) No groundwater seepage encountered
- 3) Samples taken from 0.50–1.60m (IND, MOD, CBR)

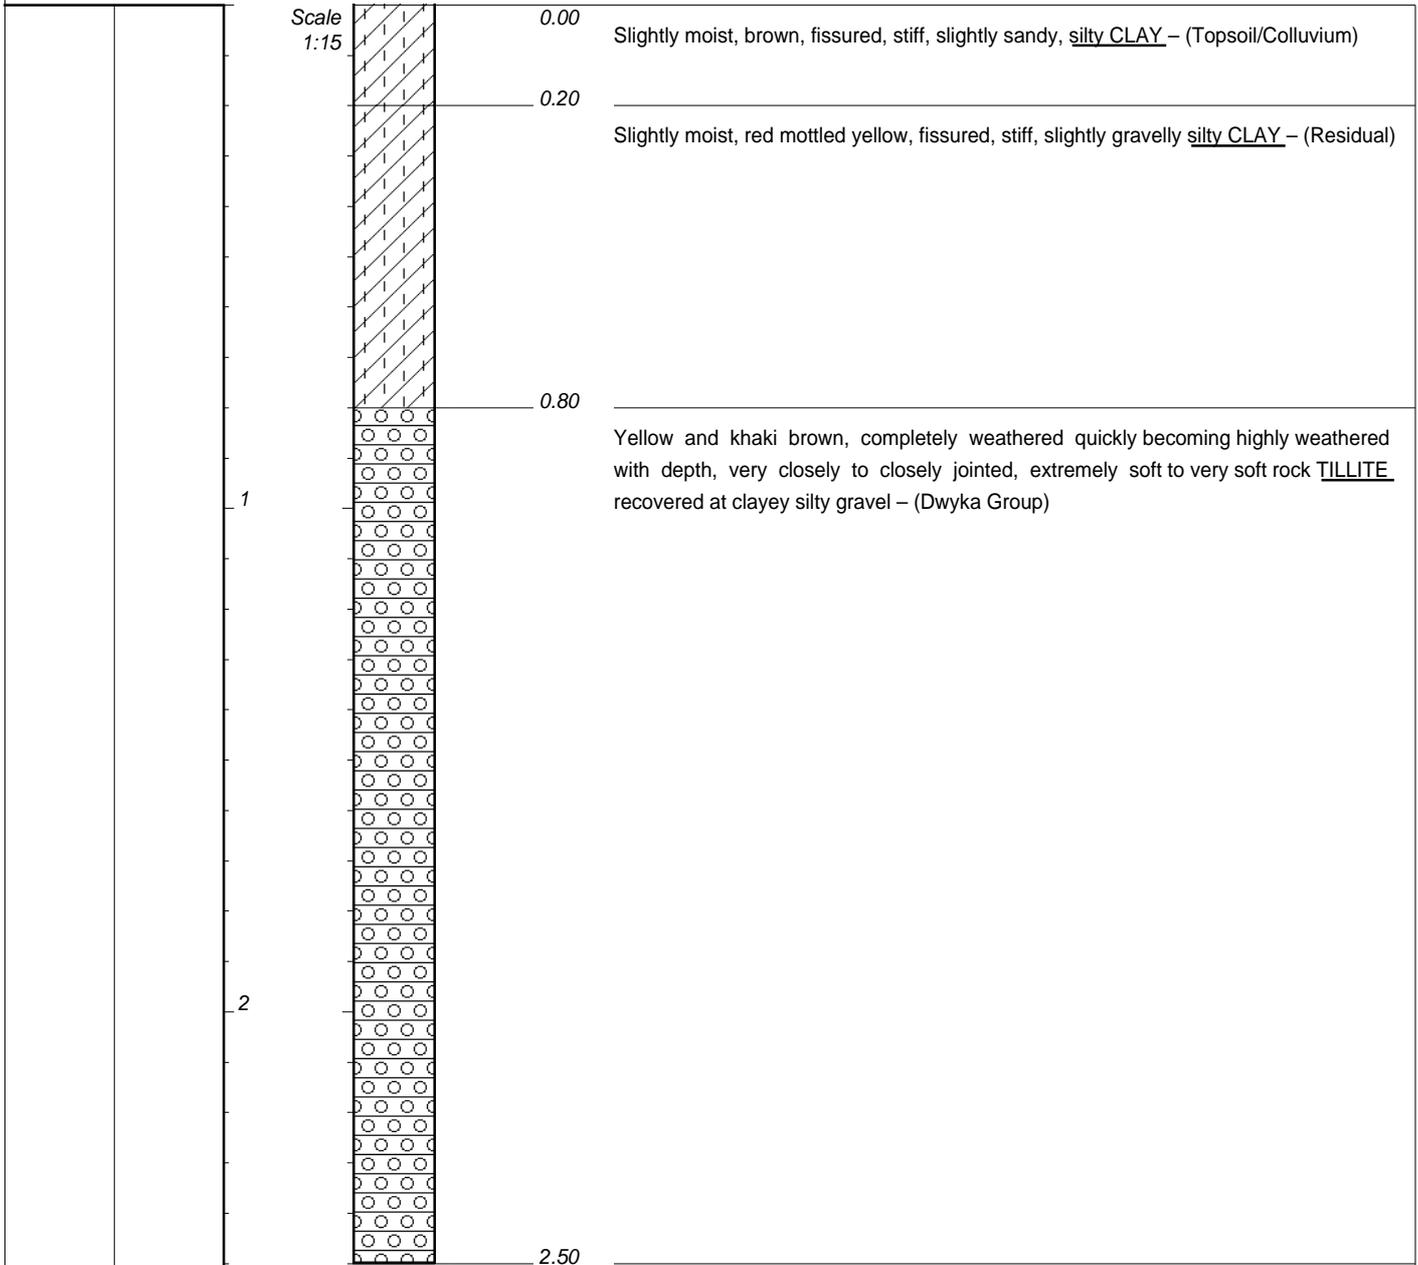
- 1) Dull refusal of excavator met at 2.5m in weathered tillite.
- 2) No groundwater seepage encountered.

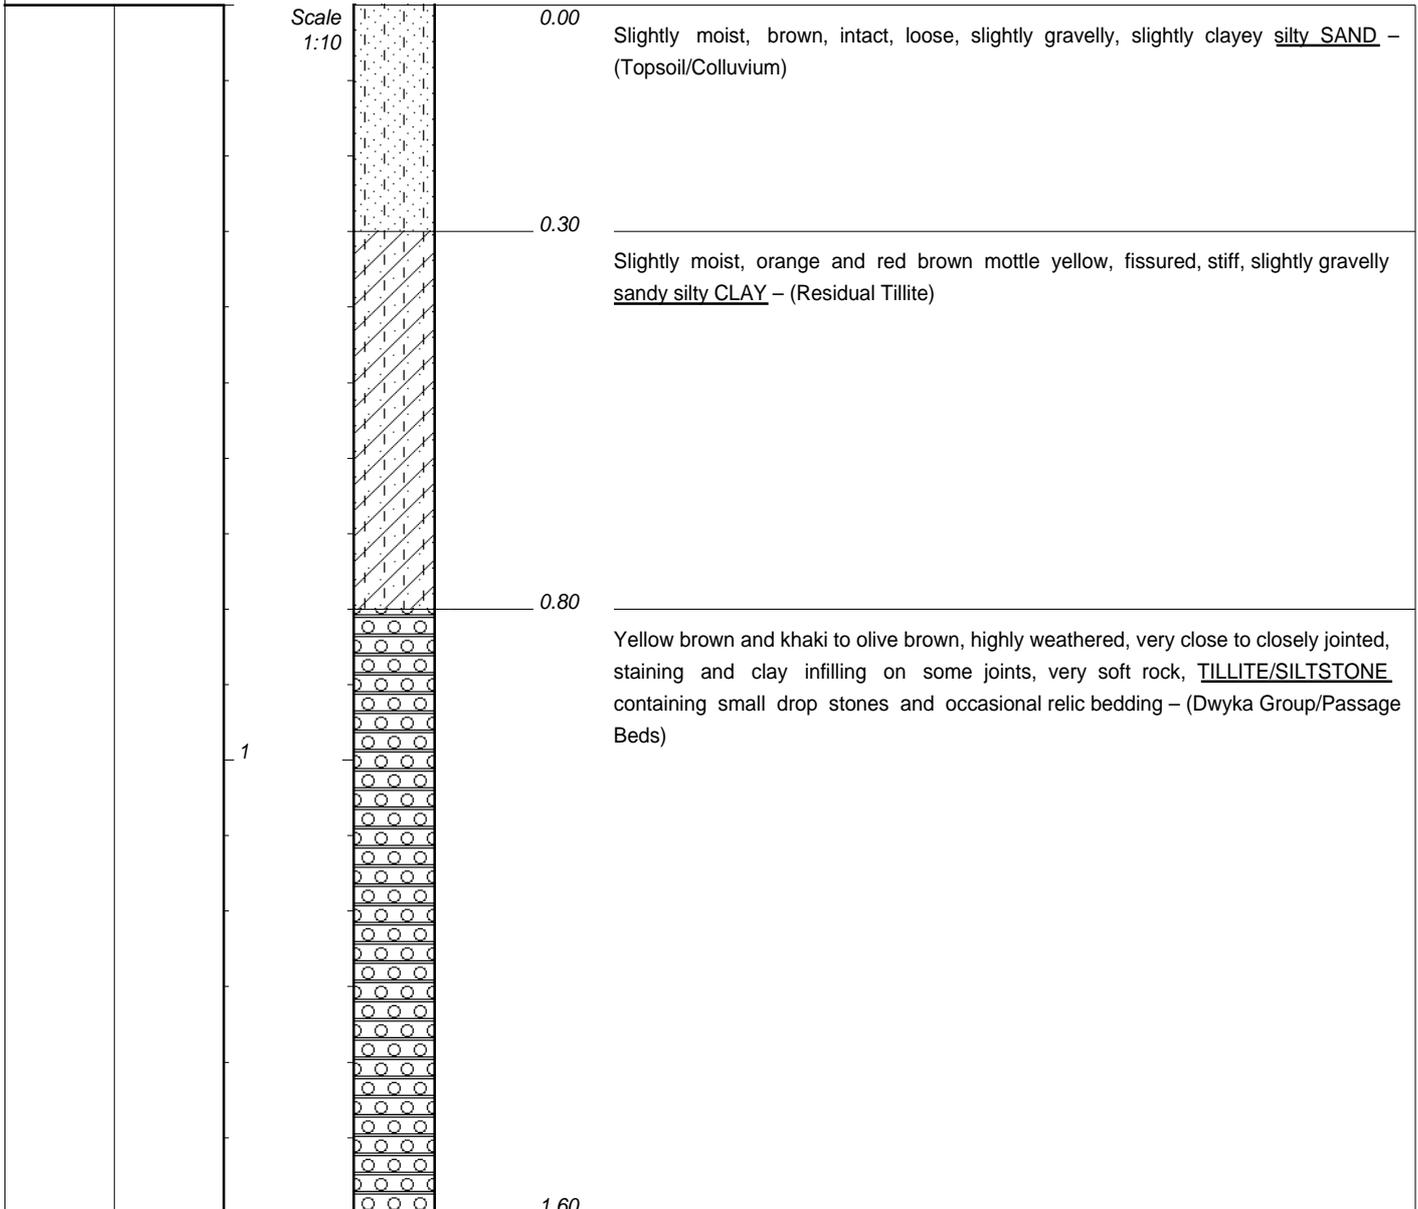
- 1) Dull refusal of excavator encountered at 1.6m.
- 2) Pit located at the base of a steep fill embankment.
- 3) No groundwater seepage encountered

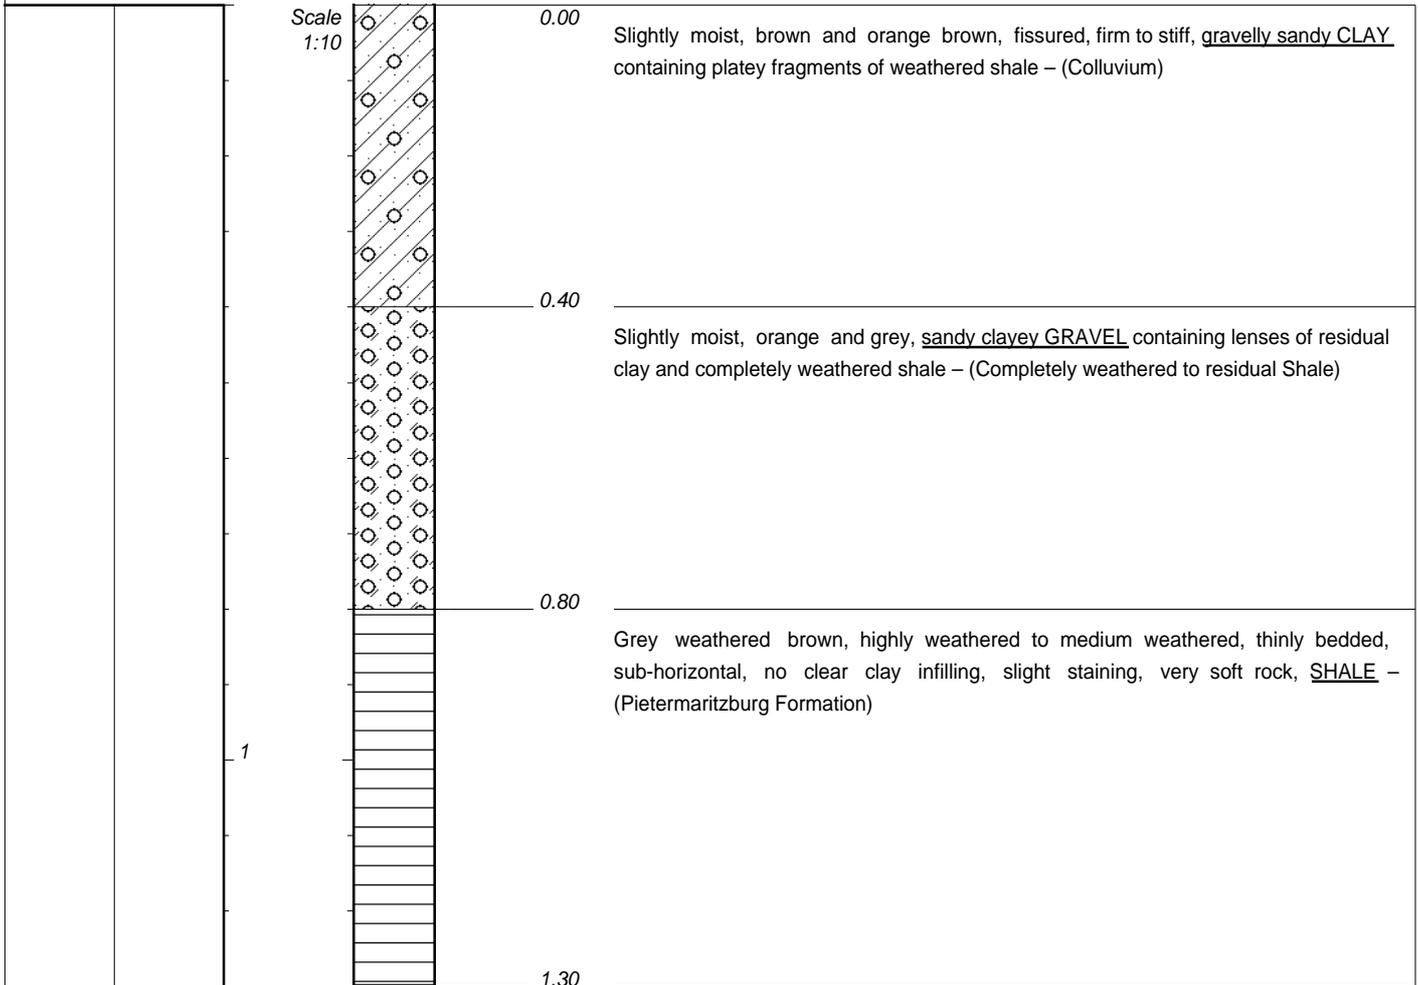
- 1) Semi refusal of excavator met at 1.3m in weathered shale.
- 2) No groundwater seepage encountered
