**Report to the Klipplaats Family Trust on a Geotechnical Investigation
carried out for the Proposed Wembezi PLS, Portion 57 (of 1) of the Farm
Klipplaat Drift No.1009, Estcourt, KwaZulu-Natal**

Project No.: 21-030R02 Rev 1

Date Issued: March 2022

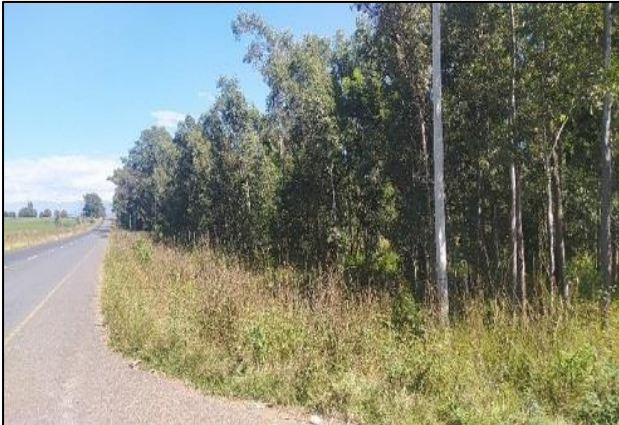
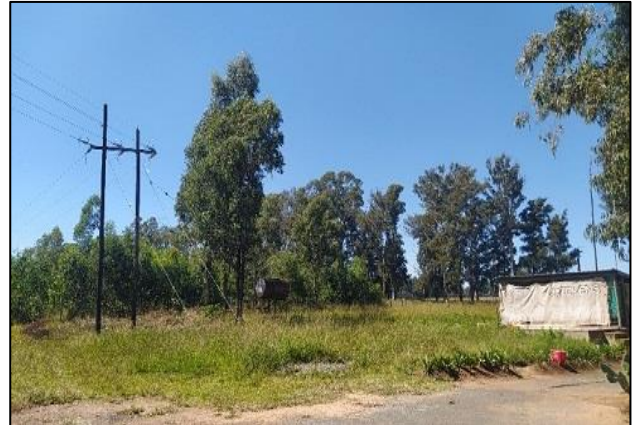
Plates 1 & 2: South to southeastern boundary of the site adjacent to the P29 road covered by a tree line which spans across most of this half-portion of the site. Note Eskom suspended powerline.

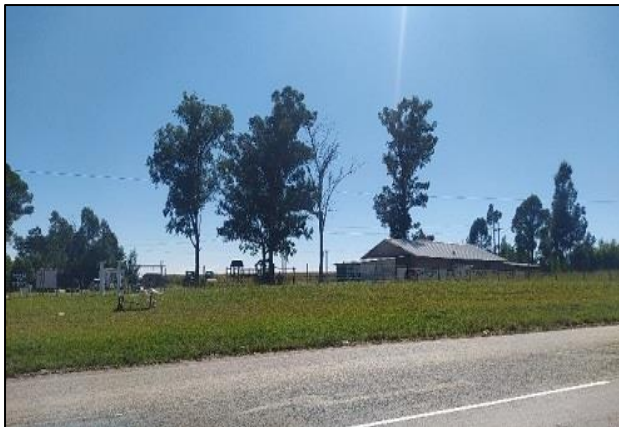
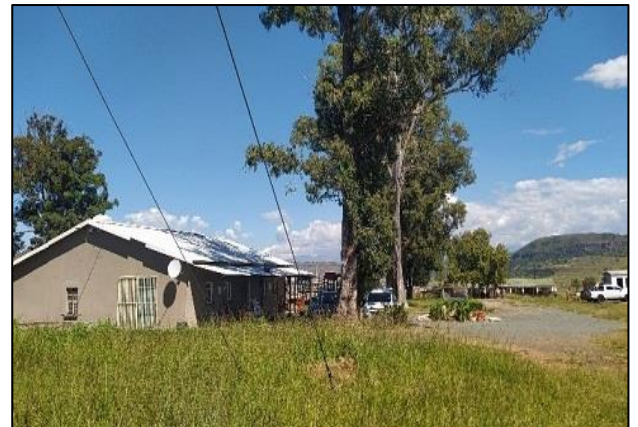
Plates 3 & 4: Southeastern-most portion where currently the site is occupied by a small farm stall at the corner of the P29 and P179 road". This area will be incorporated into the Wembezi Mall as a Service Station site

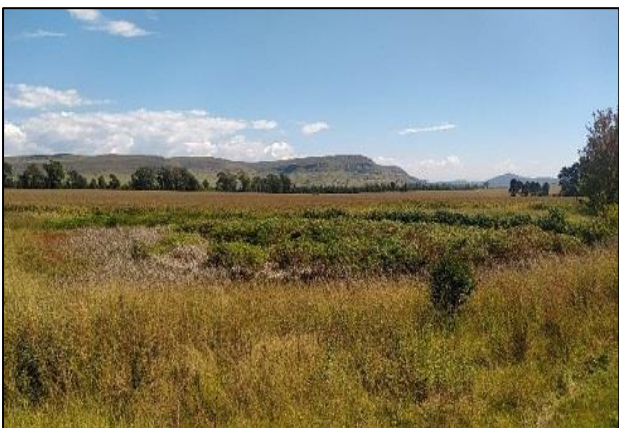
Plates 5 & 6: Past the tree line the site is predominantly flat to gently sloping towards the west. Crops are located within this portion which extend to the north/northeast beyond the site into the neighbouring farmlands

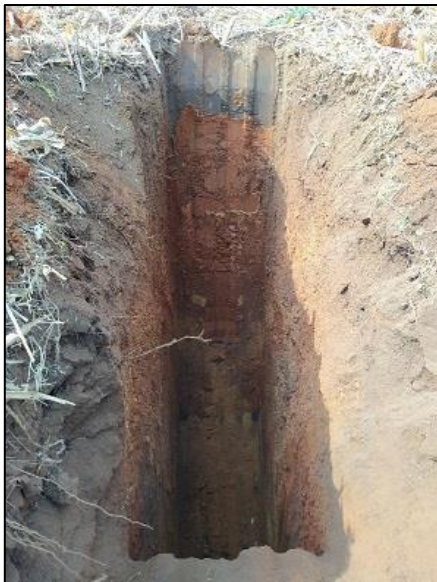
Plate 7: Typical residual siltstone soils extending to between 2.5 and 3m before grading into siltstone bedrock

Apart from TP8 in which sandstone was encountered, the residual soils grade with depth into bedrock which can be described as yellowish brown to grey stained reddish brown completely weathered thinly bedded very soft to soft rock siltstone of the Estcourt Formation. With depth the siltstone improves to soft rock in strength.

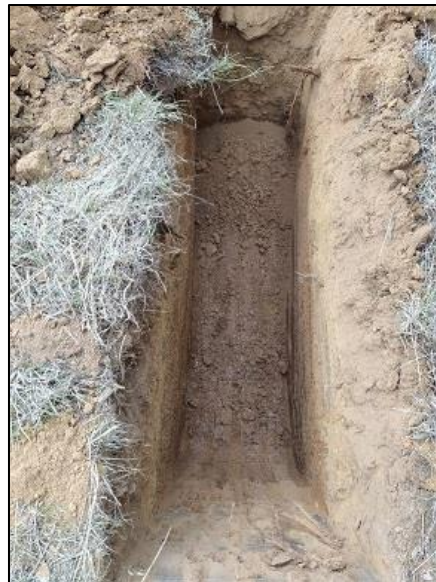
Plate 8: Shallow refusal on hardpan ferricrete horizon

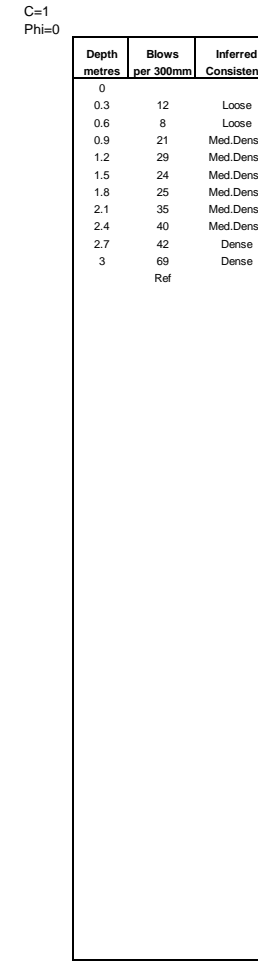
Light Dynamic Penetrometer Probe ----- **Test No.DPL 6**

THE INSITU STRENGTH DEPENDS ON SOIL MOISTURE CONTENT AND GRAIN STRUCTURE WHICH HAVE NOT BEEN ASSESSED AND MAY CHANGE. THE VALUES GIVEN ARE THEREFORE INDICATIVE ONLY AND SHOULD BE VERIFIED BY TEST OR OBSERVATION

The DPL test comprises a 25mm diameter solid steel retractable cone driven vertically into the ground using a 10 kg hammer dropped through a height of 550mm. The resistance to penetration is measured in terms of number of blow counts per 300mm advance. It should be noted that the DPL tests can refuse on stiff/hard materials, boulders, cemented layers as well as bedrock. Due to the nature of the test, in which no samples are recovered, it is not possible to determine the materials on which refusal has occurred.

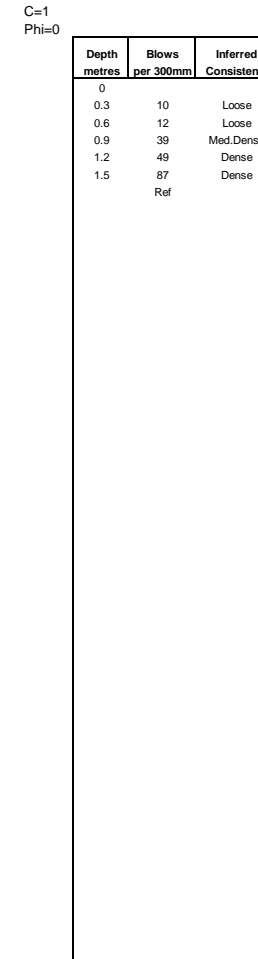
Light Dynamic Penetrometer Probe Test No.DPL 20

THE INSITU STRENGTH DEPENDS ON SOIL MOISTURE CONTENT AND GRAIN STRUCTURE WHICH HAVE NOT BEEN ASSESSED AND MAY CHANGE. THE VALUES GIVEN ARE THEREFORE INDICATIVE ONLY AND SHOULD BE VERIFIED BY TEST OR OBSERVATION

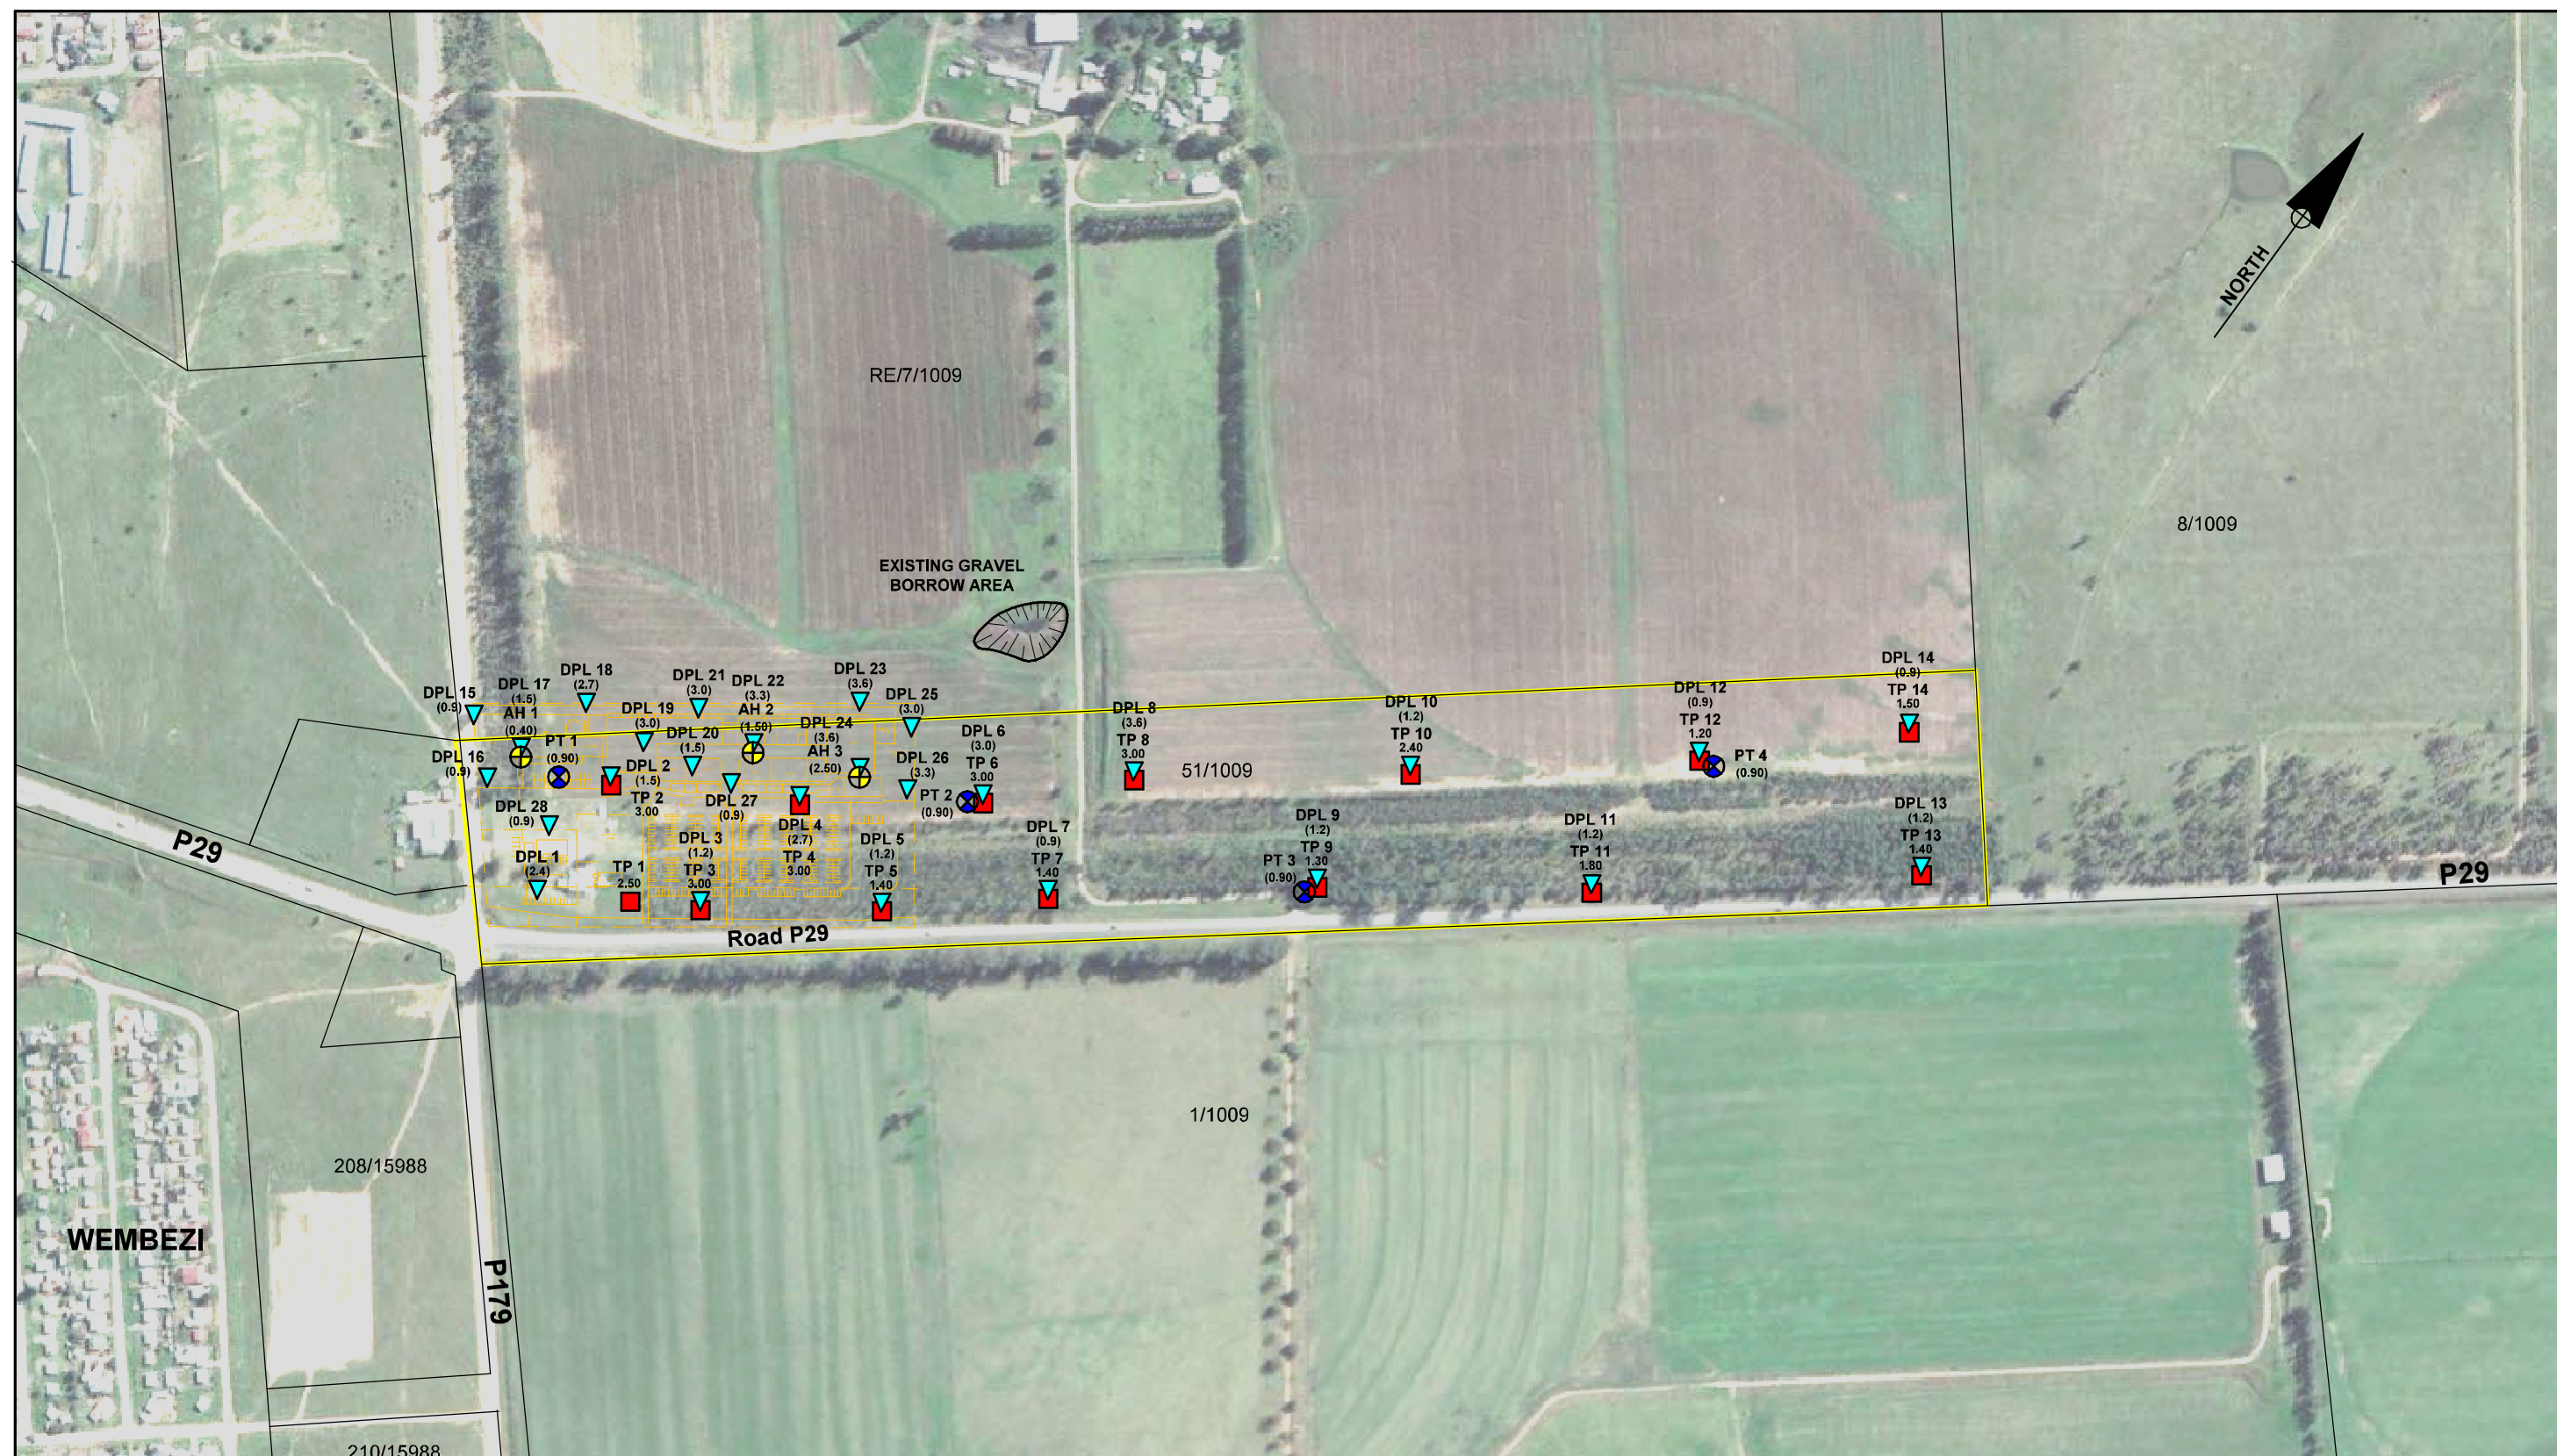
FIGURE No.
1

- TP 1**
2.50 **Approximate position of Test Pit showing final depth in metres below existing ground level.**

The general layout of the site is shown in Figure 1.
