**Report on a Hydrogeological Assessment for the Proposed Wembezi PLS,  
Portion 51 (of 7) of the Farm Kliplaat Drift No. 1009, Estcourt, KwaZulu-  
Natal**

**Project No.: 21-030R03 Rev 1**

**Date Issued: March 2022**

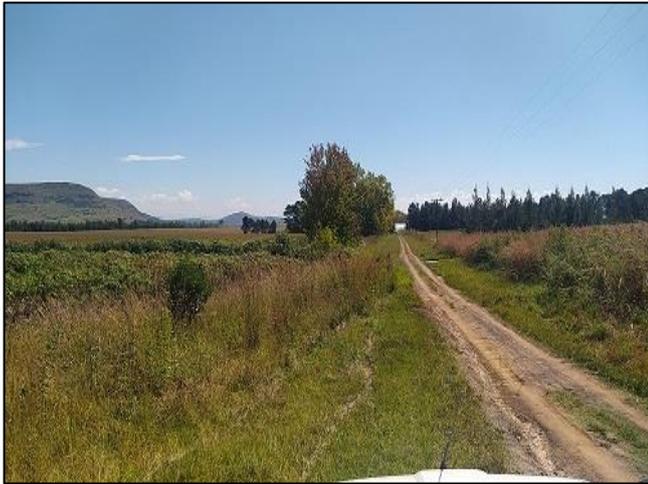
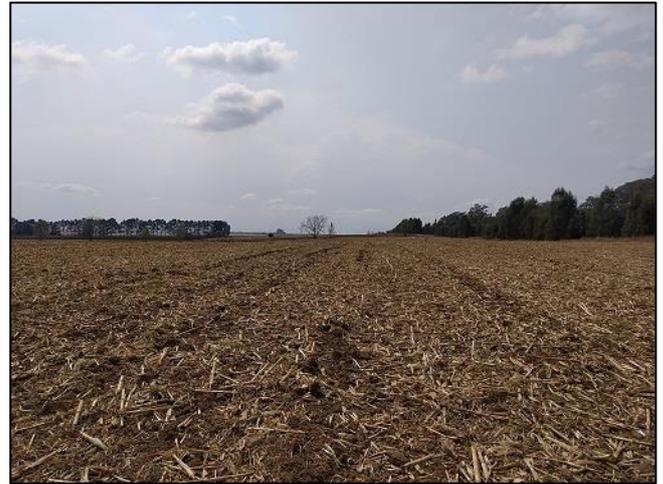
**Plates 1 & 2: View of the site which is flat to gently sloping towards the northwest**

Topographically, the elevation of the site ranges from about 1299m on the southeast, to 1305m on the north, above mean sea level. There is a general fall in gradient of some 6m over the entire 20 Ha site and it can thus be categorised as flat to very gently sloping. The slope can be classified as planar.

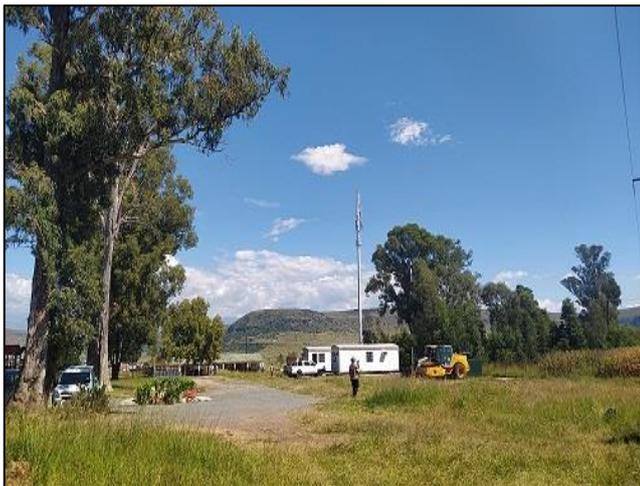
**Plate 3: View of the site at the adjacent to the road crossing in the southwest showing a flat gradient**

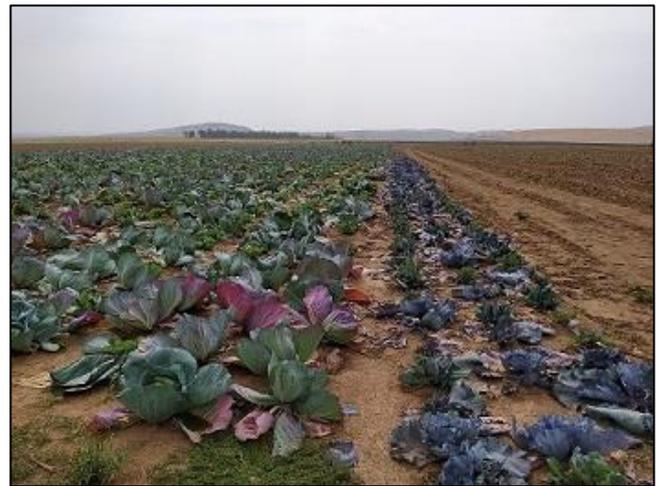
**Plate 4: Farming along the northeastern boundary of the site showing a flat gradient**

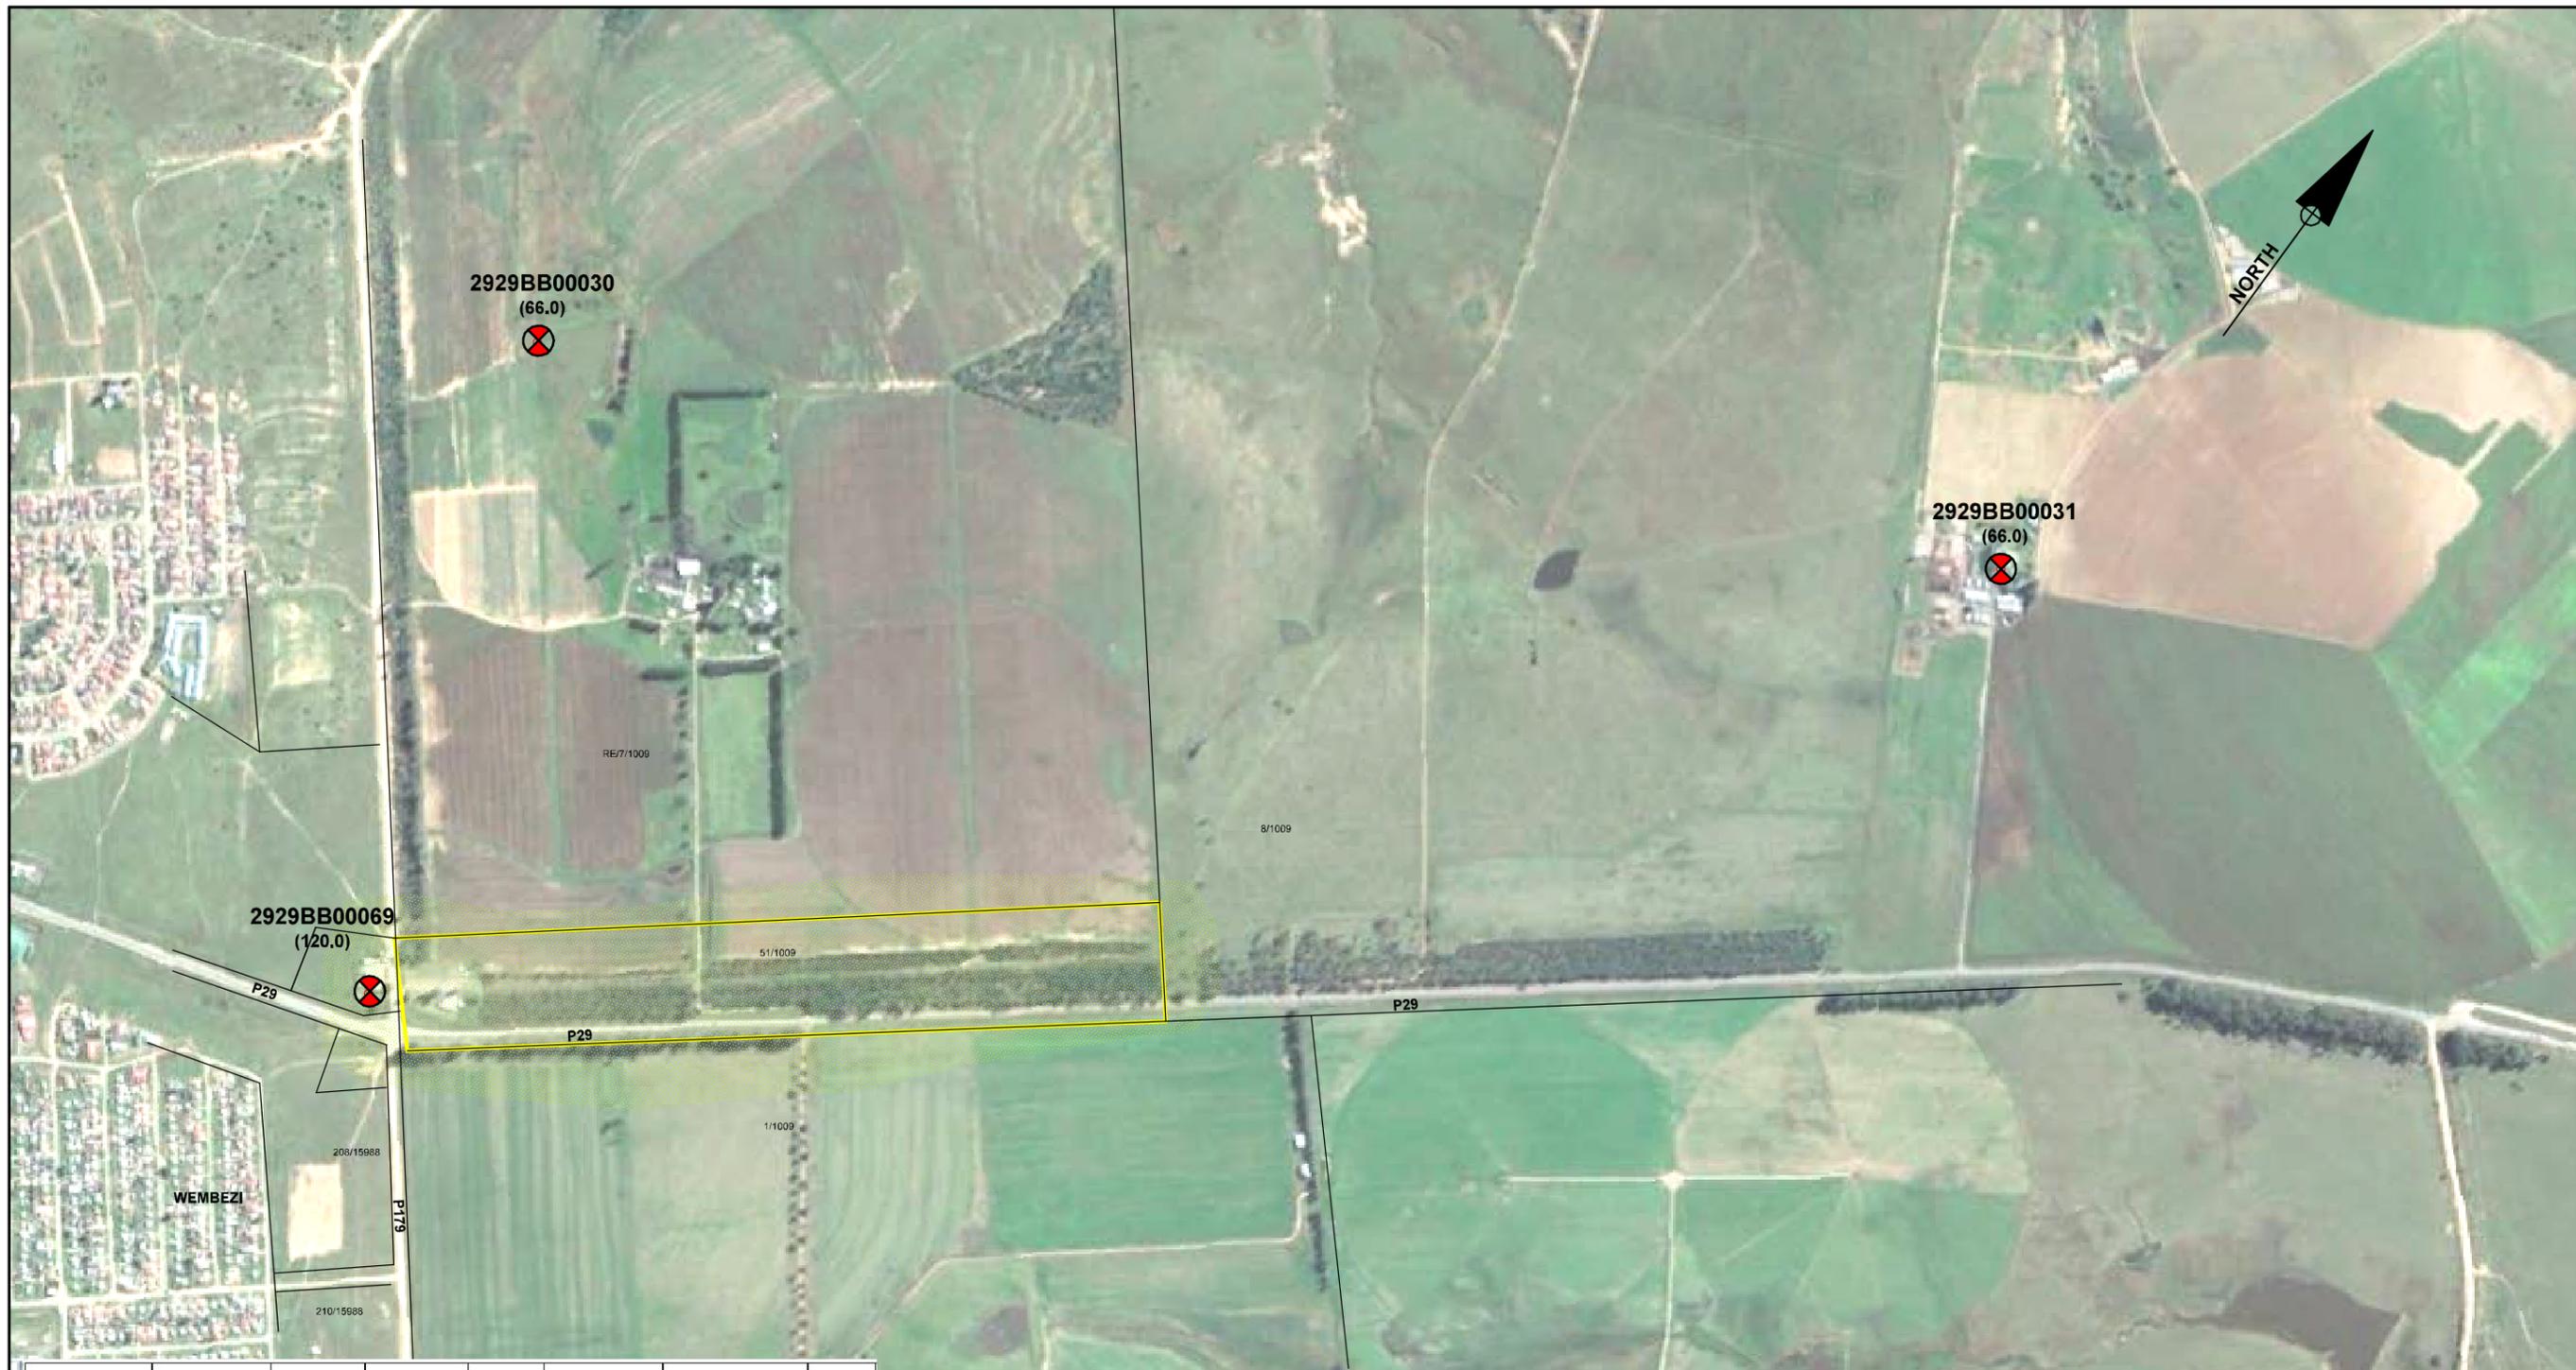
FIGURE No.	REV.
1	0

National Borehole ID	SADC Borehole ID	Latitude (WGS 84)	Longitude (WGS 84)	Depth (mbgl)	Water Level (mbgl)	Discharge Rate (l/sec)	Pump Type
2929BB00069	767633	-29.04188	29.79393	120.0	Unknown	Unknown	Blow
2929BB00031	767600	-29.02618	29.81223	66.0	Unknown	Unknown	Blow
2929BB00030	767599	-29.03338	29.79093	66.0	Unknown	Unknown	Blow

A site walkover mapping assessment was conducted in March 2021. The locality of the proposed Wembezi PLS in relation to Wembezi town is shown in Figure 1 Site Plan.

The general geology of the Wembezi area as shown in Figure 1, inferred from the 1:250 000 geological map series Durban 2930 published by the Council for Geosciences. The area is mainly underlain by the interlayered shales, siltstones and sandstones of the Estcourt Formation of the Beaufort Group. Although not evident from Figure 1, the site could also possibly be locally intruded by intrusive dolerite of Jurassic age, being a fairly common feature in the region.

A search through the Groundwater Information Portal GIS map for the area was carried out. This source identified three groundwater boreholes in the area located approximately within a 500m radius of the 20 Ha site. These boreholes were located about 50m (west), 150m (northeast) and 500m (north) of the site. The approximate positions these boreholes are shown on Figure 1.

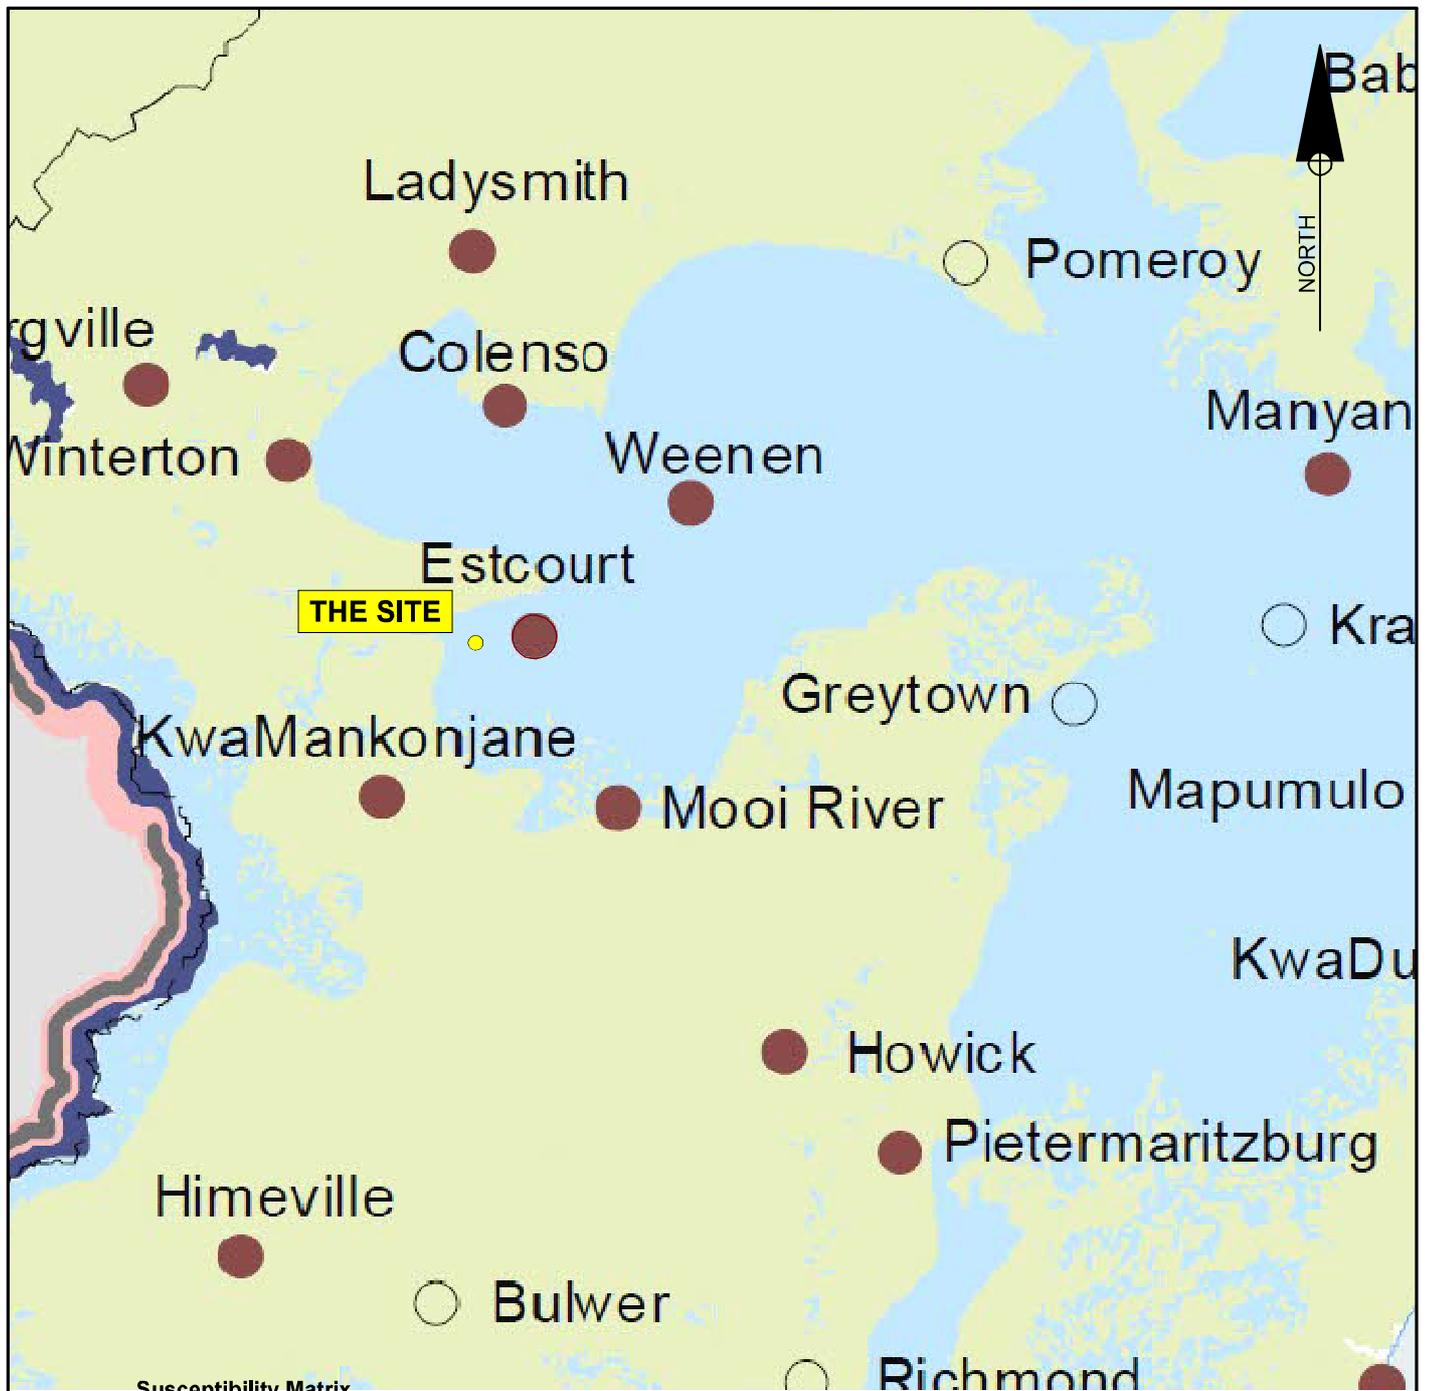
Susceptibility Matrix

AQUIFER CLASSIFICATION		
		Poor	Minor	Major
VULNERABILITY	Least	1 Low	2 Low	3 Medium
	Moderate	2 Low	4 Medium	6 High
		3 Medium	6 High	9 High
